# Review of the biomechanics, engineering design and forensic failure analysis of implantable medical devices

Bosch D<sup>1\*</sup>, Hannon P<sup>2</sup> and Anderson S<sup>1</sup>

## Case study 1 – Swan neck deformity repair

## Case study 2 - Knee implant failure

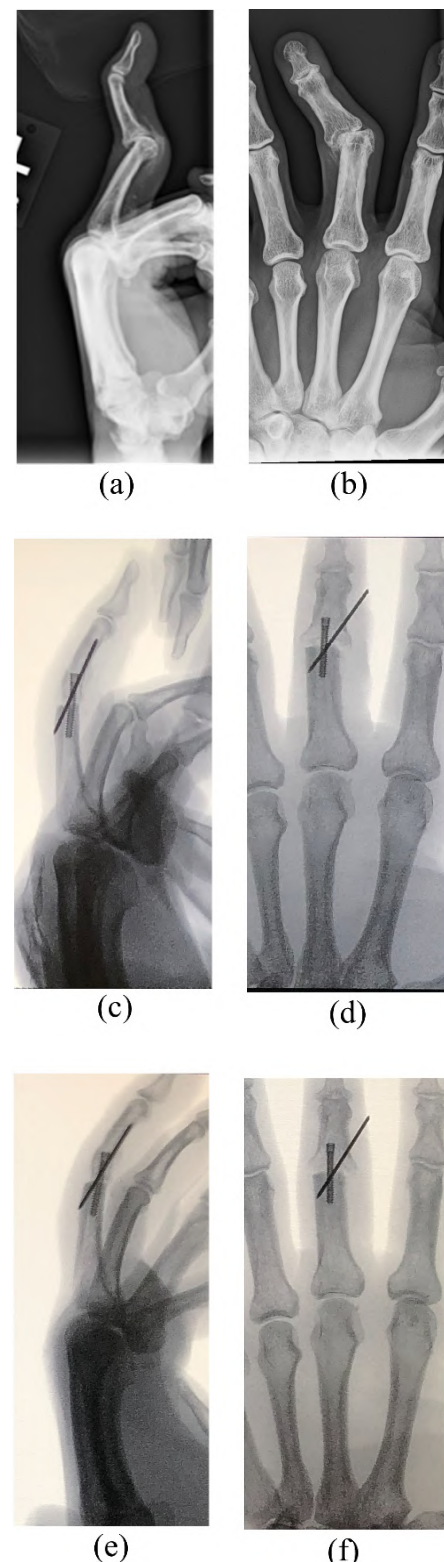
**Figure 1.** “Swan Neck” Deformity of the third Ray-PIP and DIP joints- Pre-op (a) Sagittal View radiograph, (b) Anteroposterior View radiograph, (c) Sagittal View, (d) Anteroposterior View; Fluoroscope Photo images of the same patient at 4 weeks post-op. Note woven bone has filled in the gap but remains to be fully mineralized which will require more time. The bone screw will remain in place, but the K wire will be pulled out when fusion of this proximal interphalangeal joint is more complete. Images (e) and (f) are of the same patient at 7 weeks post-op, showing better but still incomplete fusion. The K wire was pulled out after this imaging. (Courtesy of Patrick Hannon)

The ulnar deviation of the middle phalanx was likely caused by the original injury, which most likely involved a radial collateral ligament sprain of the PIP joint. This resulted in instability that allowed the extrinsic and intrinsic muscles of the middle finger (flexors, extensors, or both) to pull more toward the ulnar side of the hand, thus creating the ulnar deviation deformity. Over time, the moment arm for this ulnar pull increased, accelerating the deformity. A “Swan Neck” deformity is most commonly seen in individuals with rheumatoid arthritis, but in the present case, blood markers for this condition were negative. Rather, the swan neck deformity was the result of the instability at the PIP joint caused by changes in the volar plate, which allowed the middle phalanx to be pulled into hyperextension at the PIP joint by the *extensor digitorum* tendon of the middle finger. Without a functioning volar plate, the extrinsic finger flexor muscles (*flexor digitorum profundus* and *flexor digitorum superficialis*) were unable to counteract the pull from the opposing *extensor digitorum*. The osteoarthritis observed at the PIP joint is the consequence of abnormal intrinsic and extrinsic muscle forces being exerted on this joint without the necessary stabilizing structures needed to prevent the deformities, which led to further degeneration of the PIP joint cartilage surfaces. (Courtesy of Patrick Hannon)

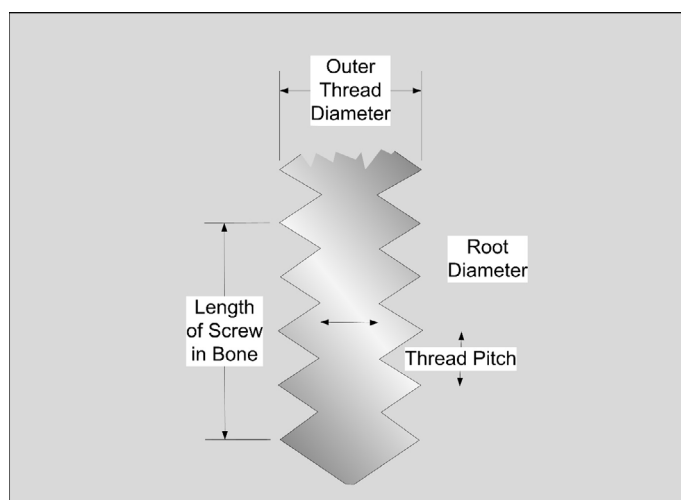
Figure 2. Screw parameters

Unstable fractures require external or internal fixation with multiple transcutaneous pins, screws, wires, plates, and rods. Good bone ends or bone fragment approximations are important for optimal healing (a satisfactory fracture reduction). A good blood supply is also very important and can be accomplished by preserving the soft tissue adjacent to the lesion site to ensure the continued blood supply to the outer and inner layers of bone periosteum. Bone screws alone may be sufficient to bring displaced bone fragments together and may be specifically designed for compact bone or for cancellous (spongy) bone (Figures 2 and 3).

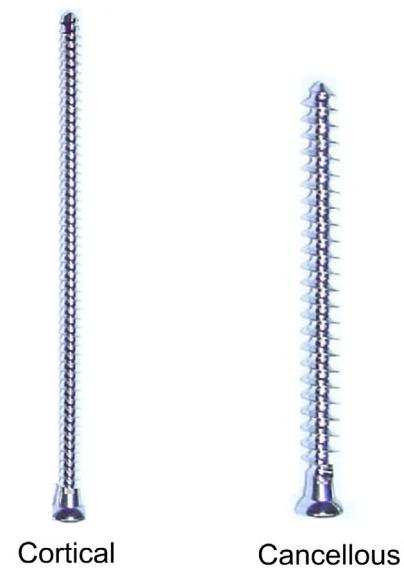
Figure 3. Types of bone screws. Bone screws may be made from stainless steel, titanium alloy, or cobalt-chromium alloy. The thread pitch is greater in cancellous bone screws, in similar fashion to “deck screws” used in carpentry. The holding capability of a bone screw is dependent upon the thread diameter times the thread length inside the bone (Kummer, 2001). Sometimes the screw holes are pre-tapped to minimize the micro-damage of screw insertion. The most important variable in screw fixation is the quality (density) of the compact (cortical) or cancellous bone. Those individuals with marked osteopenia (lower bone density) are more likely to have screw loosening and inadequate fixation. Bone screwdrivers are also equipped with a force limiting mechanism (i.e., similar to a torque wrench) to prevent the stripping of bone caused by too much torque during screw insertion. (Kummer, 2001)

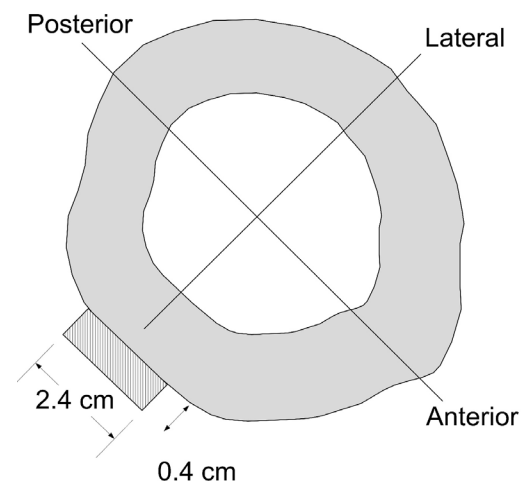
Figure 4. The “area moment of inertia” or “polar moment of inertia” (closed cylinder) may be increased with fracture fixation hardware. This example illustrates how a metal plate is much more rigid (resistant to bending) in anterior-posterior bending because of the increased height (2.4 cm) of the metal plate

Sometimes metal plates are also attached by means of bone screws and are most critical on the side of the bone that is exposed to tension stresses as the result of bending loads, but may be applied to both sides of the bone for better fixation. These plates or rods are also made from similar metal alloys. These plates can also protect the bone during torsion loads and the shear, tension, and compression stresses. These same stresses are also applied to intramedullary devices (rods) inserted into the long bone intramedullary cavity. The hardware itself may also fail, and Kummer states that “sometimes there is a race between healing of the bone and fracture, usually by fatigue, of the device” [17] (Figure 4).

In some cases, internal hardware is designed to stay in permanently, while in other cases the hardware may be removed later after satisfactory bone reduction, fixation, and healing has occurred (Figure 4).

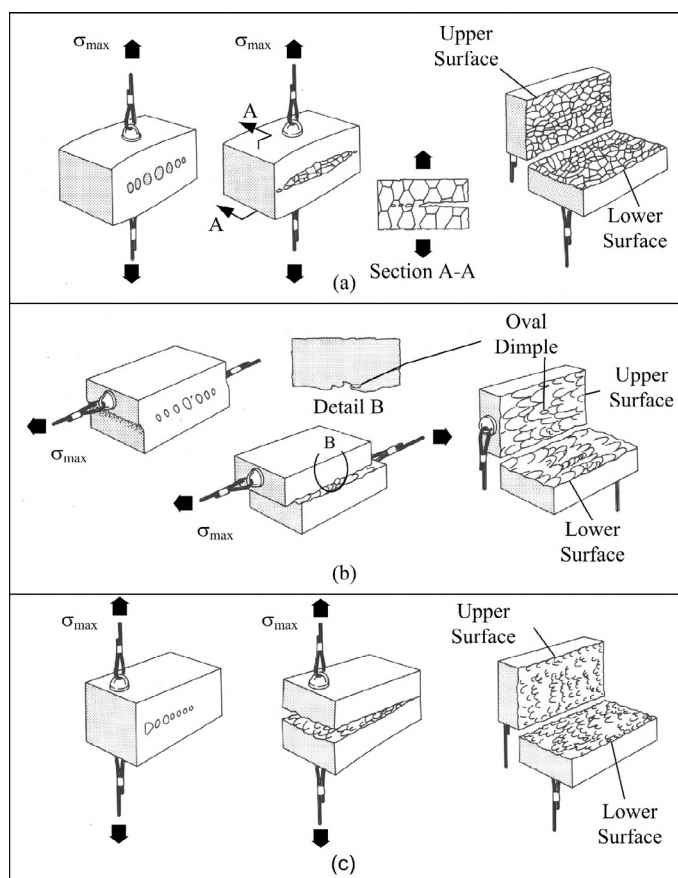
**Figure 5.** Process of Microvoid Development and Coalescence in Material Subjected to Maximum Stress ( $\sigma_{max}$ ). (a) Equiaxed dimples formed by material under uniaxial tensile strain. (b) Elongated dimples formed by material subjected to shear strain. (c) Elongated dimples formed by material subjected to tensile tearing. (Adapted from ASM Metals Handbook, Vol. 12)

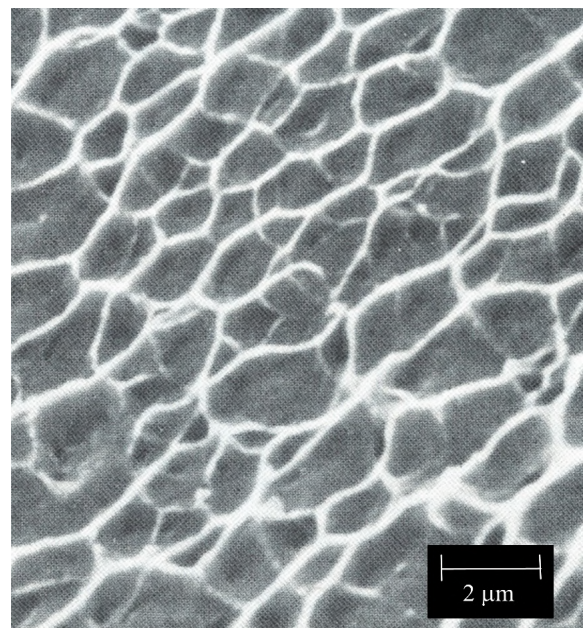
**Figure 6b.** Examples of Ductile Dimple Patterned Fracture Surface. Shallow dimples

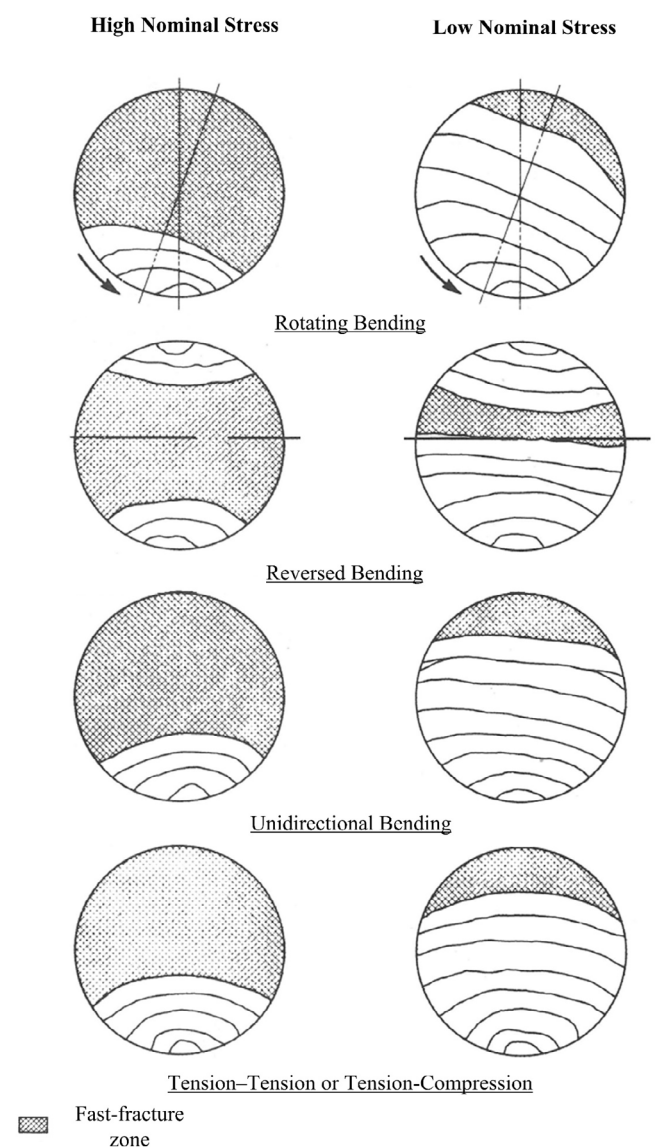
**Figure 7.** Fatigue Fracture Surface Feature Patterns Under Different Loading Conditions. (Adapted from ASM Handbook Vol. 11)

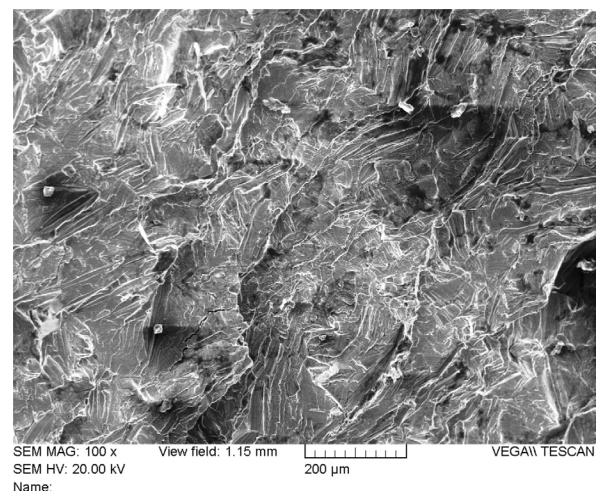
**Figure 8.** Example of Fatigue Fracture Surface Patterns on CP Titanium at Mag. = 1,000X

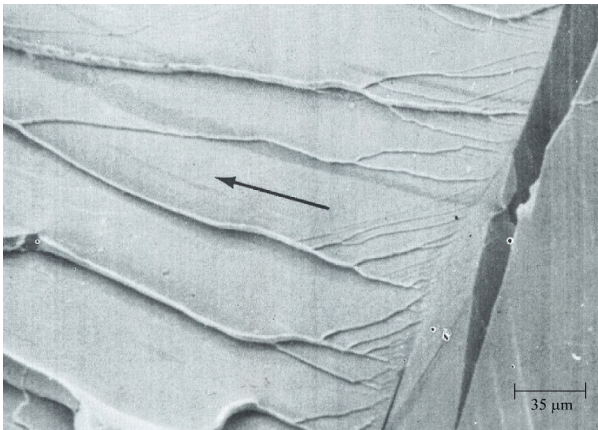
**Figure 9.** Example of Cleavage Fracture Surface Patterns. (Adapted from ASM Metals Handbook, Vol. 12)

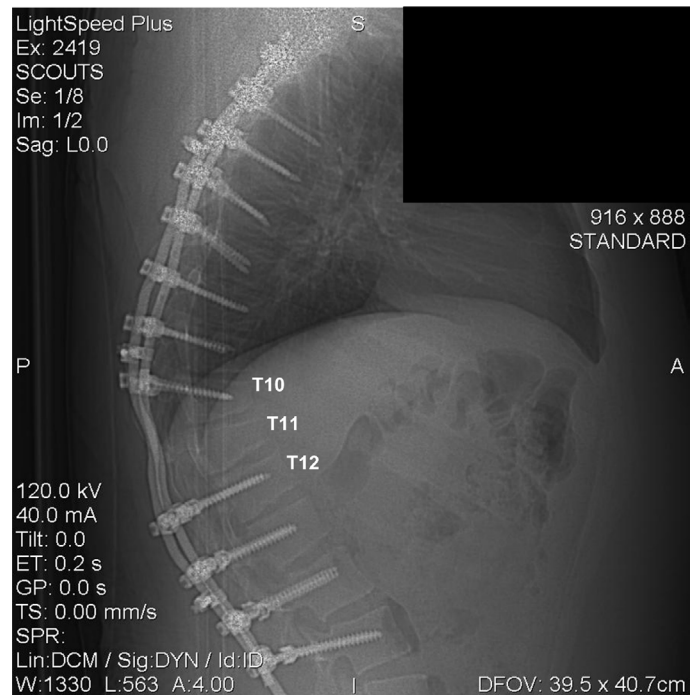
**Figure 10.** Radiograph of Relative Distances Between the Rod Attachment Hardware. (November 2005)

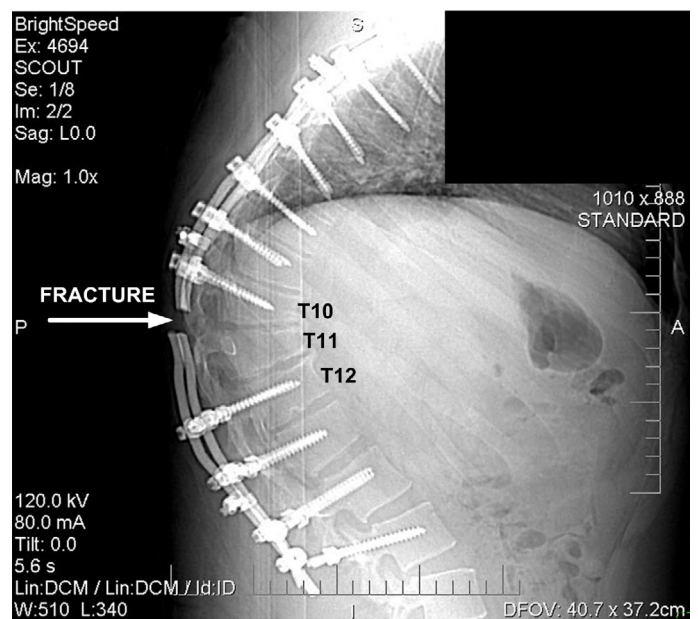
**Figure 11.** Radiograph of Fractured Rods, Rod Attachment Hardware and Spine. (November 2008)

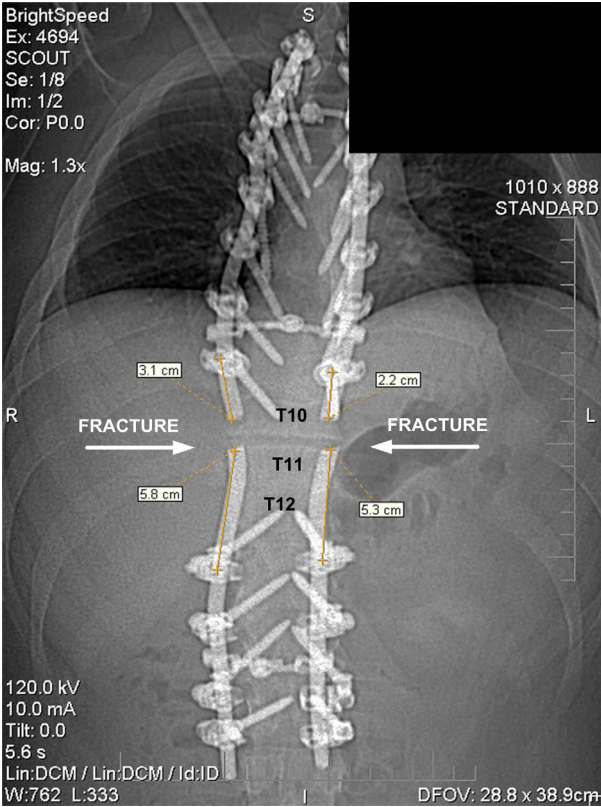
Figure 12. Radiograph of Fractured Rods, Rod Attachment Hardware and Spine (November 2008)

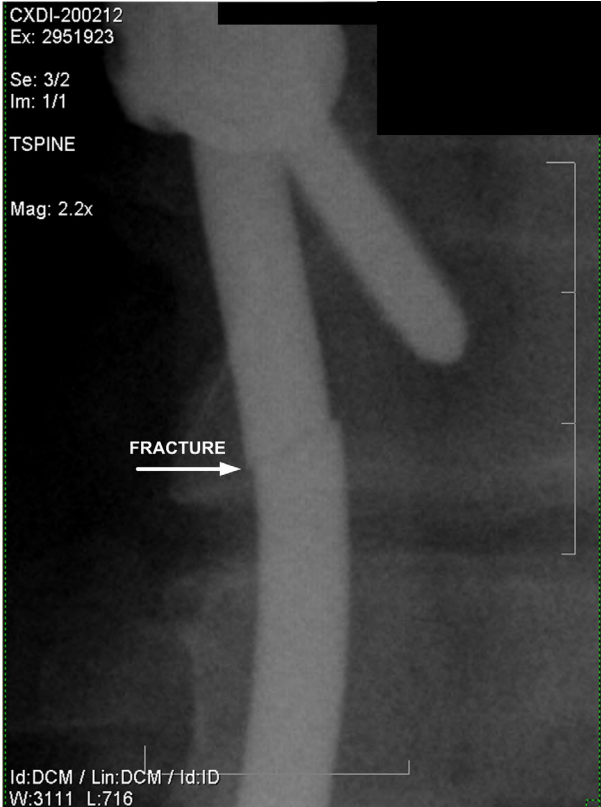
Figure 14. Anteroposterior Magnified View of Fractured Rod. (October 2006)

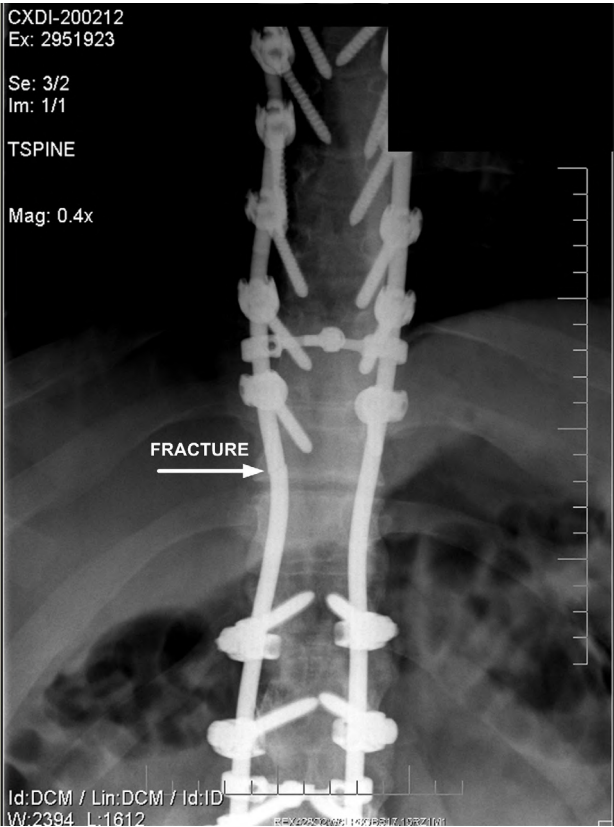
Figure 13. Anteroposterior View of Fractured Rod. (October 2006)

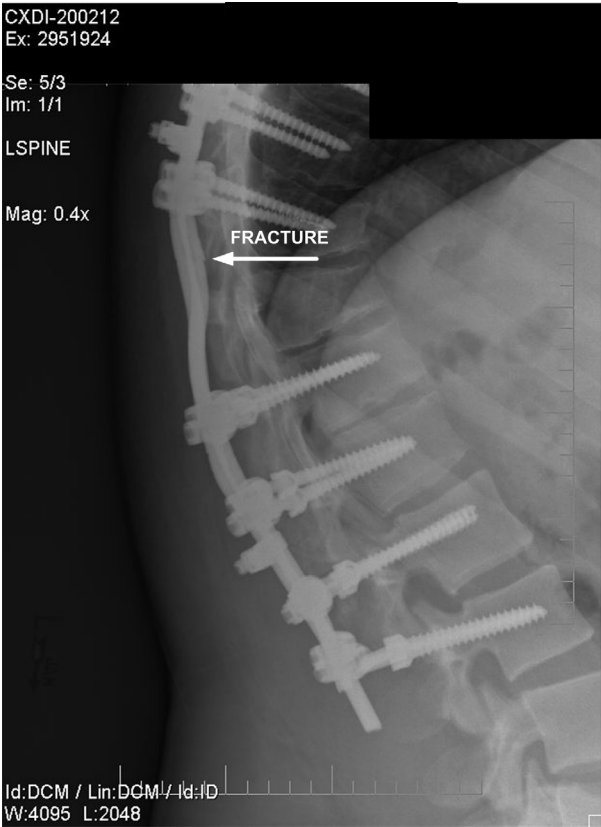
Figure 15. Lateral View of Fractured Rod. (October 2006)

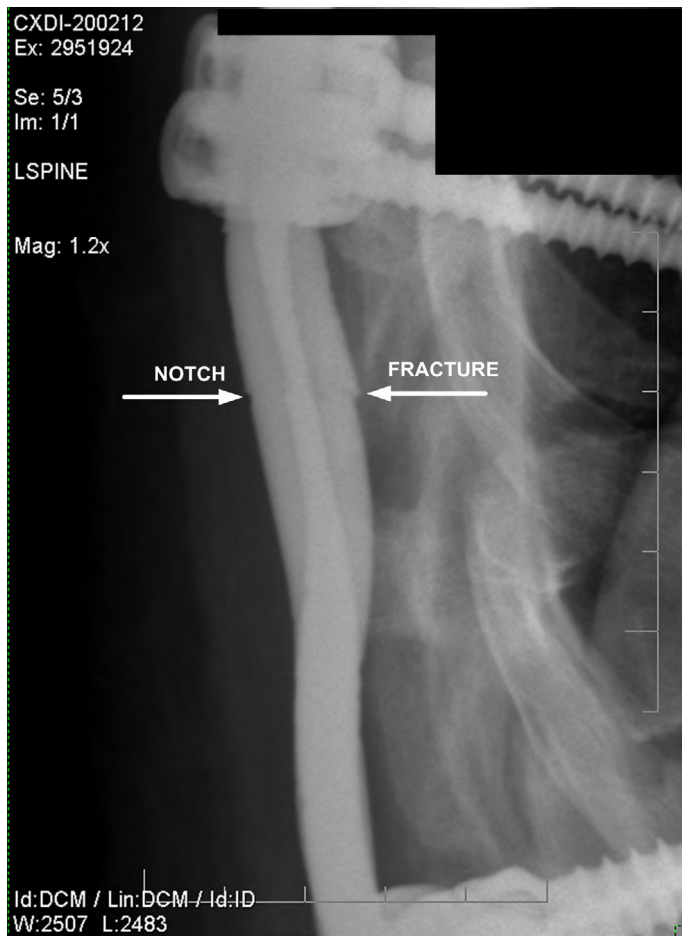
Figure 16. Lateral Magnified View of Fractured Rod. (October 2006)

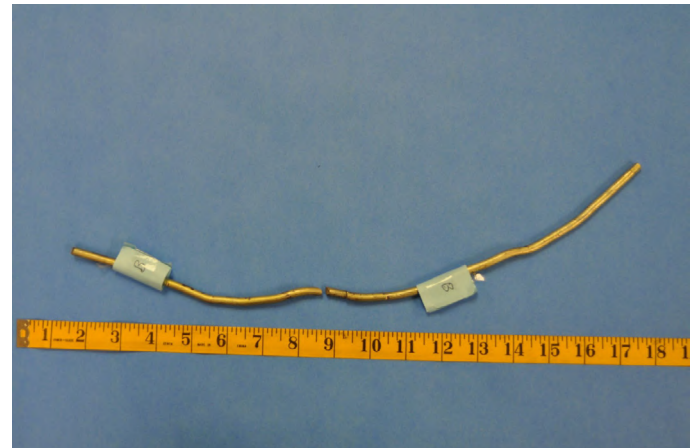
The explanted spinal support rods, as they were received, were labelled "A" and "B", and are shown in Figures 17 and 18 respectively. Close views of the fracture areas for rods "A" and "B" are shown in Figures 19 and 20 respectively.

Figure 18. Explanted Rod "B"

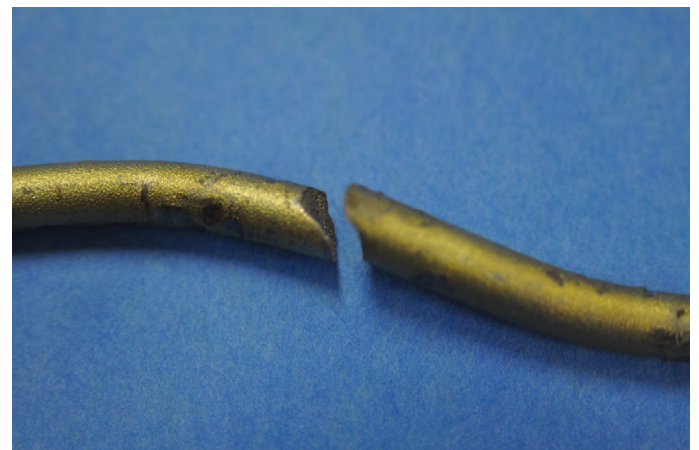
Figure 19. Close View of Fracture Area Rod "A"

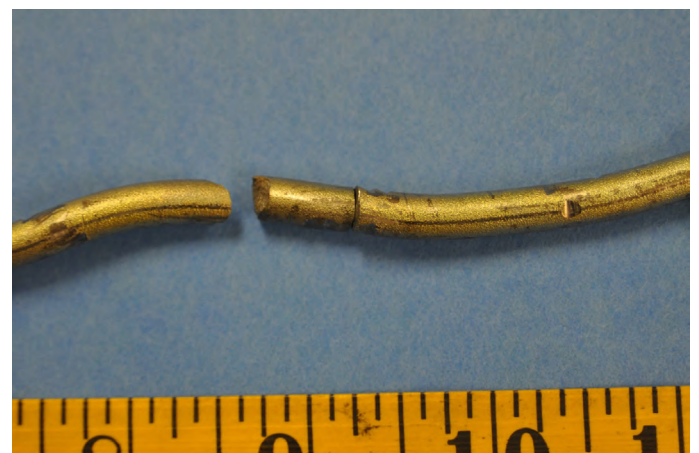
Figure 20. Close View of Fracture Area Rod "B"

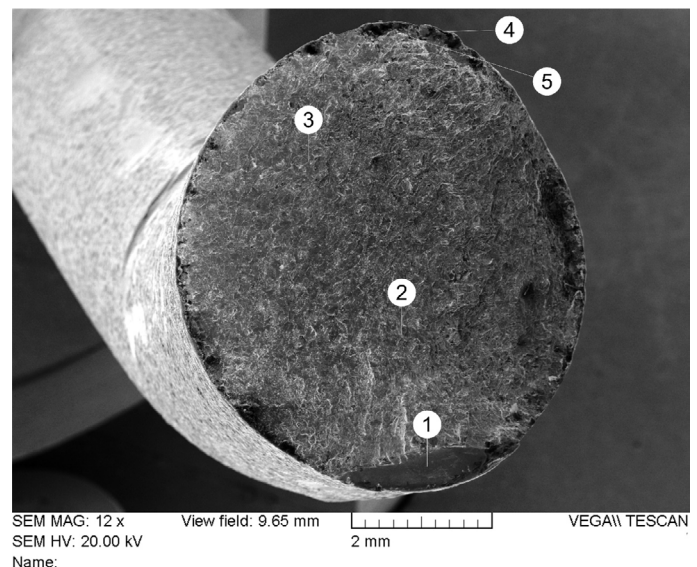
The spinal support rod fracture surfaces were examined using scanning electron microscopy (SEM) and energy dispersive x-ray spectroscopy (EDX). Figure 23 shows an electron-micrograph of the fracture surface of rod “A” at 12X magnification. The surface was examined using higher magnification at several locations. It was determined that the great majority of the surface was covered with fatigue striations as shown in Figures 24-27. Ductile dimples could also

**Figure 23.** Image of Fracture Surface of Rod “A”. Numbers 1 through 5 Correspond to Location of Images Shown in Figures 24 through 28 respectively

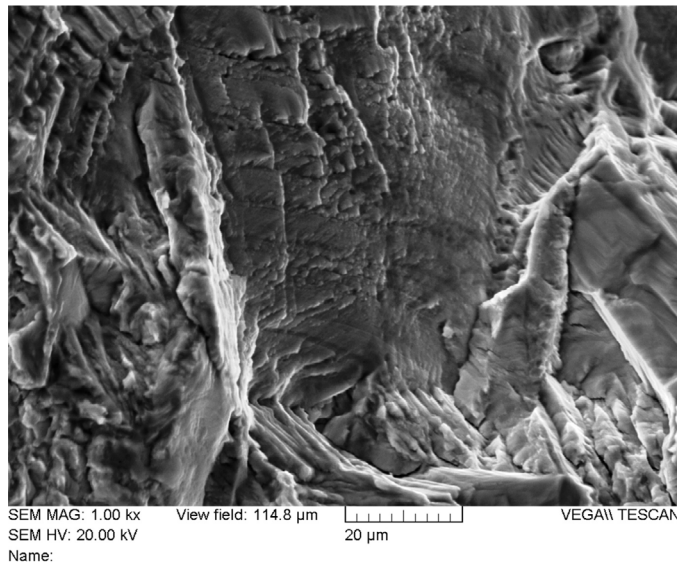
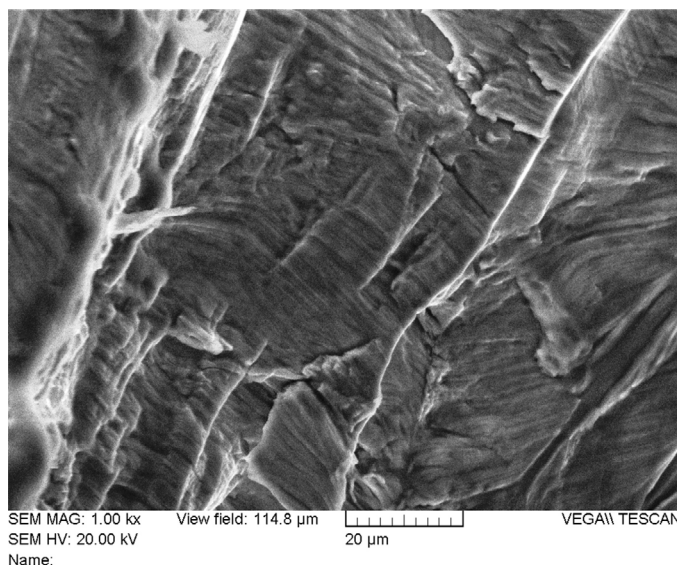
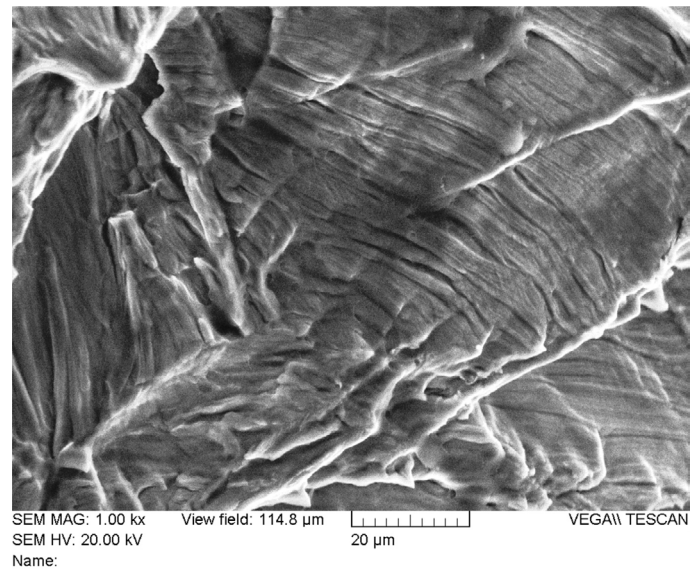
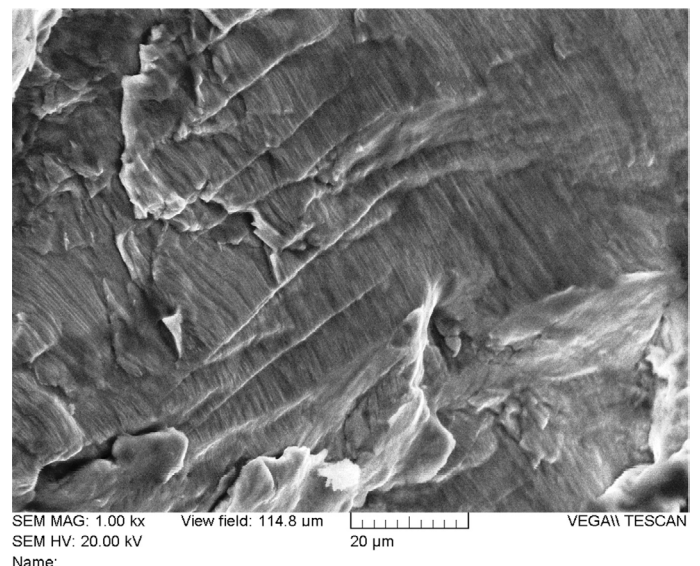
Examination of the relevant documents, along with examination and testing of the physical evidence, revealed that the subject rods failed over time by fatigue crack growth due to stress magnitudes consistent

**Figure 24.** Fatigue Striations on the Fracture Surface of Rod “A” (Location 1)

**Figure 25.** Fatigue Striations on the Fracture Surface of Rod “A” (Location 2)

**Figure 26.** Fatigue Striations on the Fracture Surface of Rod “A” (Location 3)

**Figure 27.** Fatigue Striations on the Fracture Surface of Rod “A” (Location 4)

with those expected from the walking ambulation and the normal every day activity of the patient. The fracture surface features were not consistent with a single impact overload failure. In other words, the motor vehicle accident in which the patient was involved was not the root cause of the failure of the back support rods. There was no evidence of cleavage-related failure mechanisms.

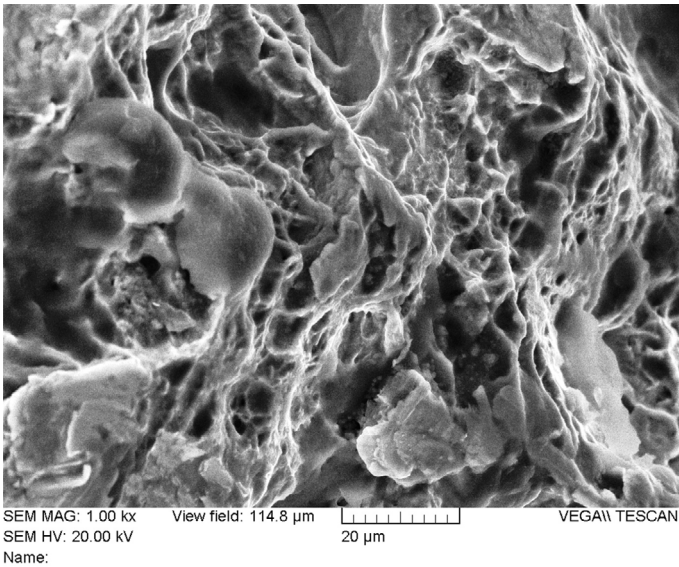
be seen in a small portion of the final fracture surface near the fracture surface edge, as shown in Figure 28.

**Figure 28.** Ductile Dimples on the Outer Edge of the Fracture Surface of Rod “A” (Location 5)

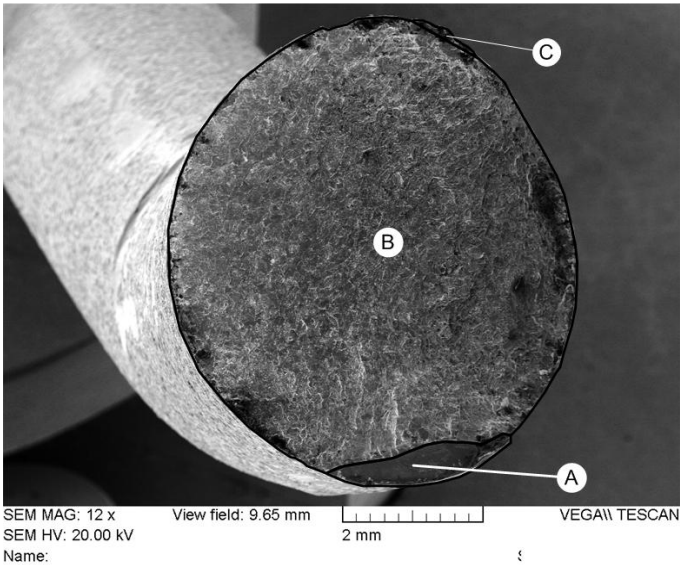
**Figure 29.** Summary of Rod “A” Fracture Surface Features. Area A – crack initiation; Area B – crack propagation by fatigue; Area C – final failure in overload

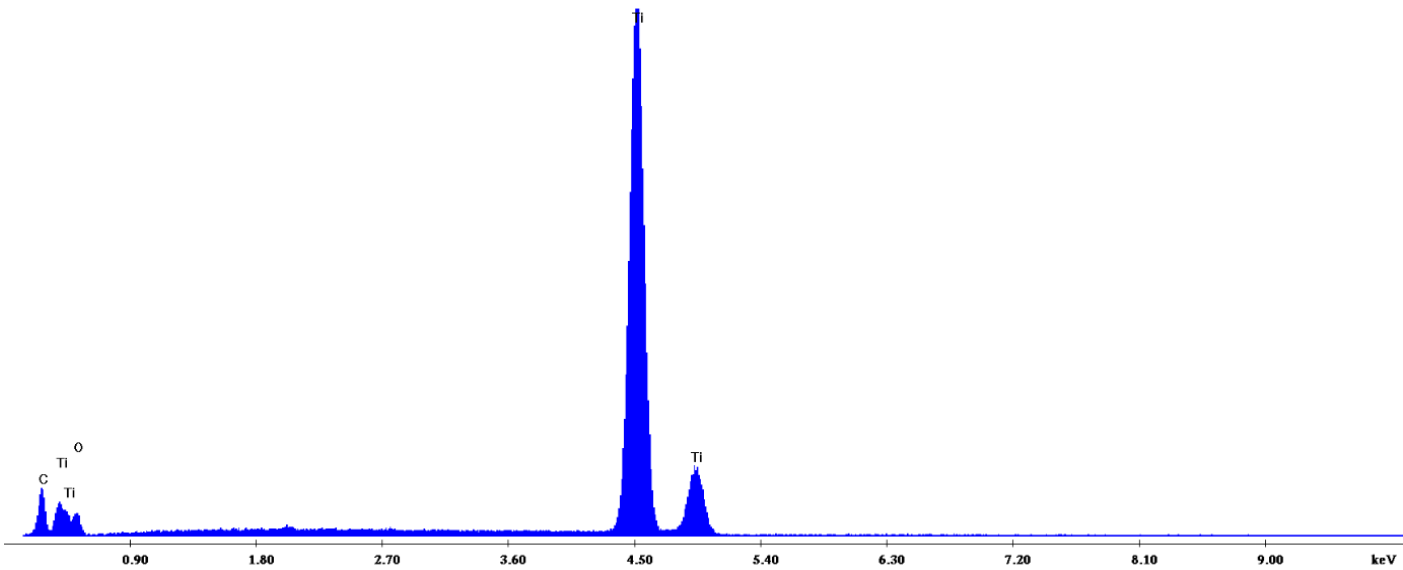
Label A: Sample 2 Fracture Surface 20kV

**Figure 30.** EDX Spectra for Rods “A” and “B”

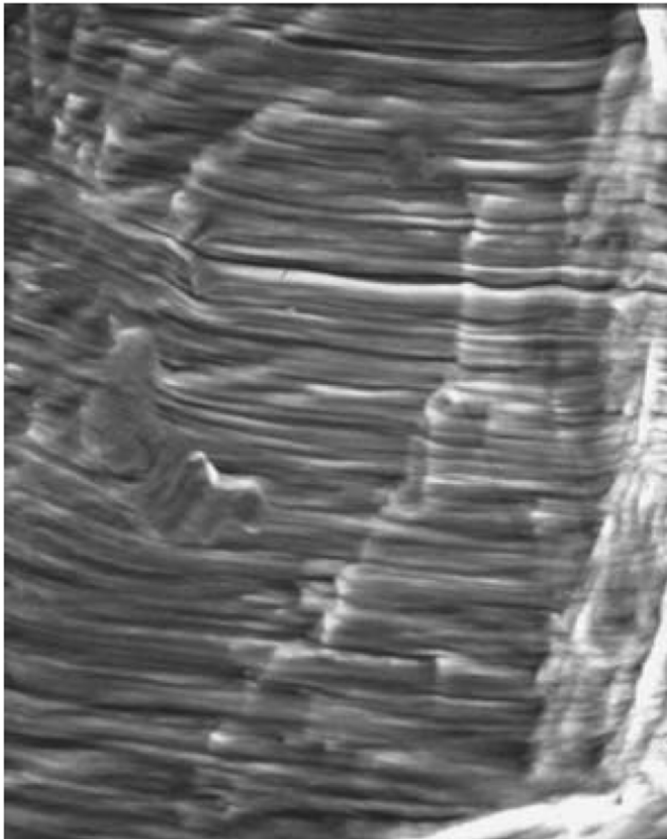
**Figure 31.** Fatigue Striations on the Fracture Surface of a Commercially Pure Titanium Specimen at Mag. = 1,000X. (Adapted from ASM Metals Handbook, Volume 12)

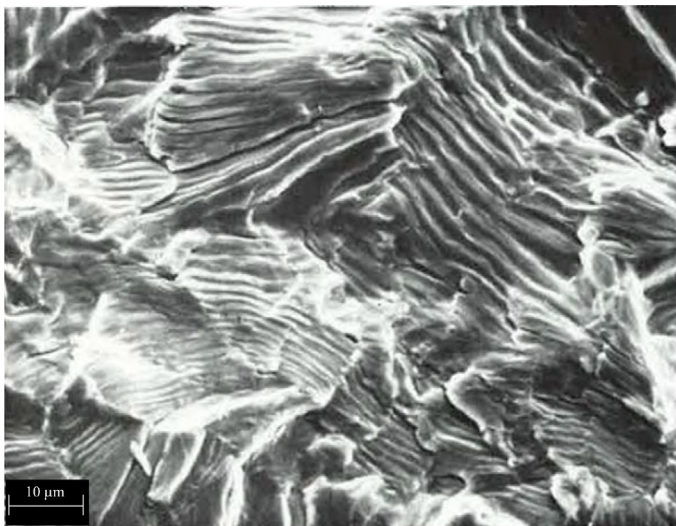
Failure analysis and fractography revealed that the failure cause (surface damage) and mechanism (fatigue) for rod “B” was essentially identical to that of rod “A”. The fracture surfaces curve from a plane perpendicular to the rod at the origin to an angle at the fast fracture zone. This type of behavior is more typical of a fatigue fracture, where the direction of stress would change slightly as the cracks propagated Figure 32.

**Figure 32.** Fatigue Striations on the Fracture Surface of a Commercially Pure Titanium Specimen at Mag. = 5,000X. (Adapted from Biomedical Materials, Narayan, 2009)
