# Spontaneous dissociation in total hip revision arthroplasty at the femoral head-neck interface

## Abstract

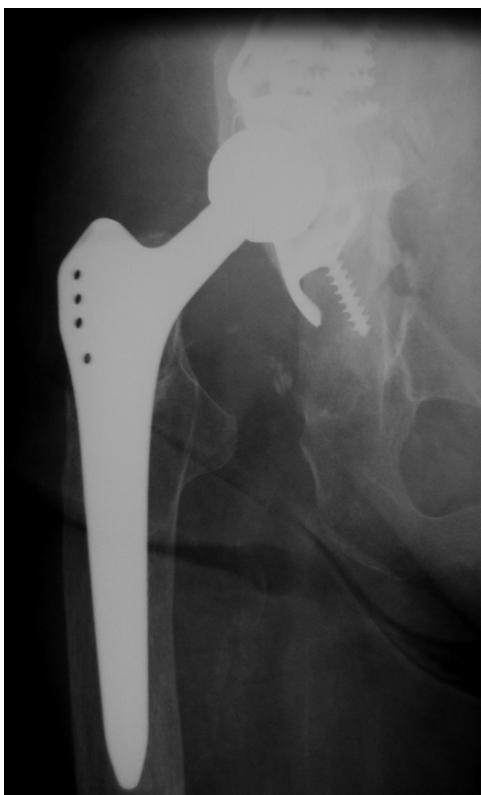
**Figure 1.** X-ray of the right hip (ap view): Total hip arthroplasty with a stable stem with no signs of loosening, destruction of the greater trochanter and reconstruction of the acetabulum using an acetabular reinforcement ring.

Clinical examination revealed limping due to insufficiency of the pelvotrochanteric muscles. ROM was fine with extension / flexion 0/0/100°, abduction/adduction 20/0/20°, external rotation/ internal rotation 30/0/30°. Scar was normal. X ray of the right hip showed a stable stem with no signs of loosening, destruction of the greater trochanter and reconstruction of the acetabulum (Figure 1).

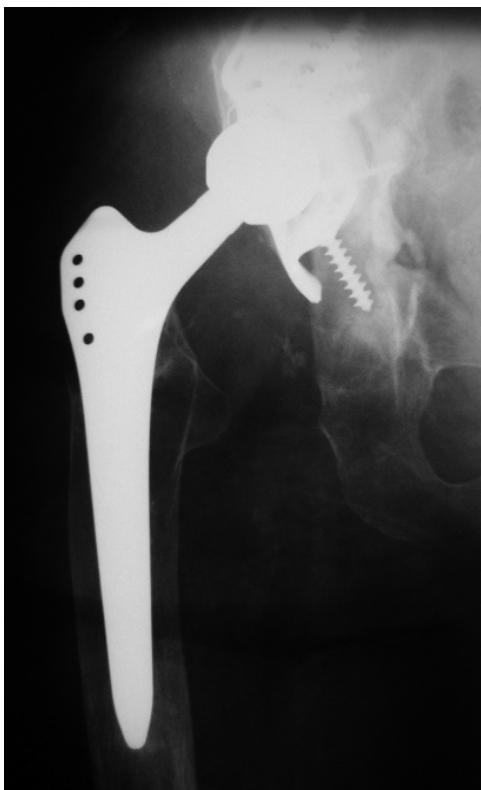
**Figure 2.** X-ray of the right hip (ap view): Total hip arthroplasty with a stable stem with no signs of loosening, destruction of the greater trochanter, radiolucent lines in zone I-III according to DeLee of the acetabular component

In July 2007 the patient suffered from pain of the right hip. X ray of the right hip showed radiolucent lines in zone I - III according to DeLee of the acetabular component (Figure 2).

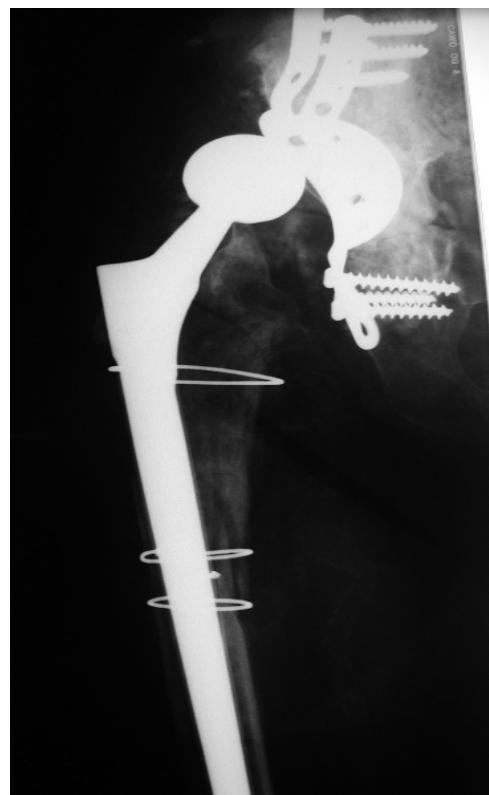
**Figure 3.** X-ray of the right hip (ap view) shows a dislocated wagner revision stem with 3 cerclage wires and reconstruction of the acetabulum with massive bone transplants.

reconstructing of the acetabulum with a reinforcement device and a Wagner revision stem and 3 cerclage wires elsewhere. 3 weeks later rerevision was performed due to recurrent dislocation using a longer head. Another dislocation occurred 2 months later with shortening of the right leg which was external rotated (Figure 3). Closed reduction was performed. 3 months later x-ray control was performed to evaluate the bony transplants (Figure 4). 2 years later in 2010 the patient presented herself again at our institution with no pain concerning her right hip but inability to walk; since several months she was using a wheel chair there was no history of trauma. The right leg seemed to be shortened and external rotated. ROM was painfully limited.

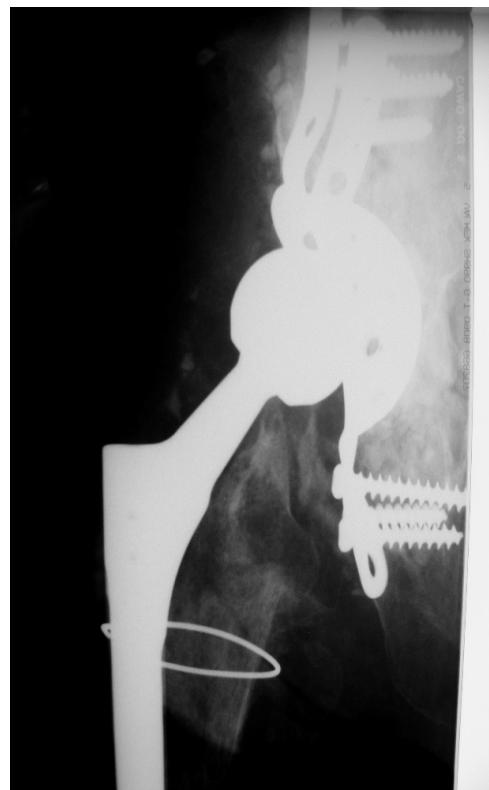
**Figure 4.** X-ray of the right hip (ap view) shows a wagner revision stem and reconstruction of the acetabulum with increasing bony ingrowth of the bone transplants.

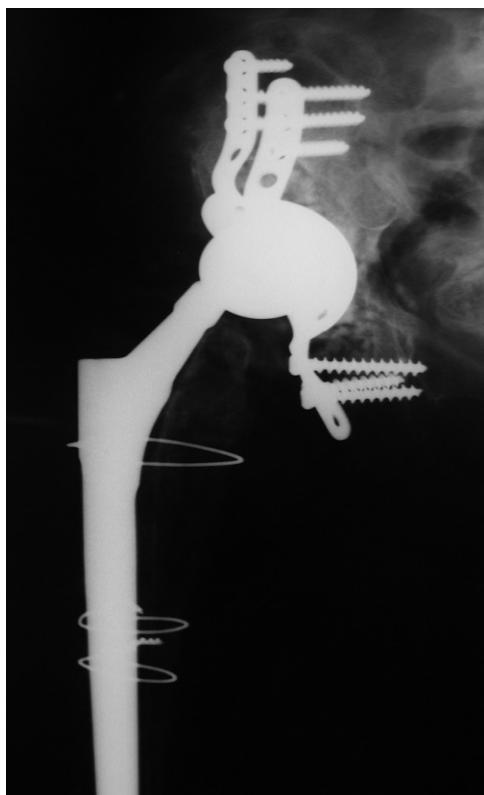
X-ray of the right hip showed a stable reconstruction of the acetabulum and the Wagner revision stem but dissociation of the head from the cone (Figure 5). We recommended revision of the hip but till today the patient is unwilling to undergo any revision surgery of the right hip. She is still using a wheel chair.

**Figure 5.** X - ray of the right hip (ap view) shows a stable reconstruction of the acetabulum and the Wagner revision stem but dissociation of the head from the cone with the head articulating with the cup.
