Case Report

Fracture of the cone of a morse taper junction in revision arthroplasty of the hip

Key words: MRP titan revision stem, fracture, cone, morse taper junction, modular

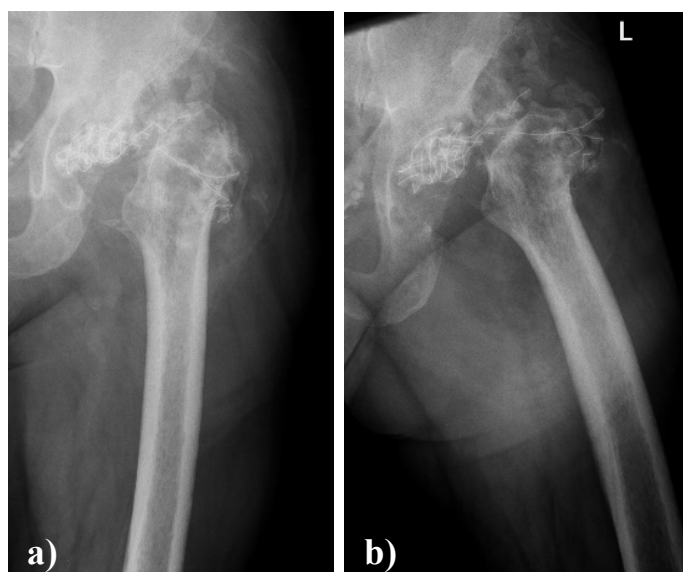
Figure 1. X-ray of the left hip in 2 planes: ap view a. and lateral; b. view shows a girdlestone situation following septic arthritis of the left hip with staph. aureus.

In August 2013 THA was performed due to a girdlestone situation after septic osteoarthritis of the hip (Figure 1) in a 46 year old male patient using a MRP Titan revision stem (Diameter: 18mm, length: 140 mm) (Peter Brehm GmbH, Weisendorf, Germany) and a cementless cup (Allofit - IT; Diameter 54 mm, Zimmer, Warsaw, USA) and a ceramic on ceramic bearing (head diameter: 36 mm) (Figure 2). The patient was 175 cm tall and weighed 105 kg (body mass index: 34.3 Kg/m²). 2 weeks later revision surgery due to recurrent dislocation (Figure 3) was performed. Revision of the acetabular component was done using an Allofit - Classic- cup, Diameter 56 mm (Zimmer, Warsaw, USA)). The neck component was exchanged from small to medium size

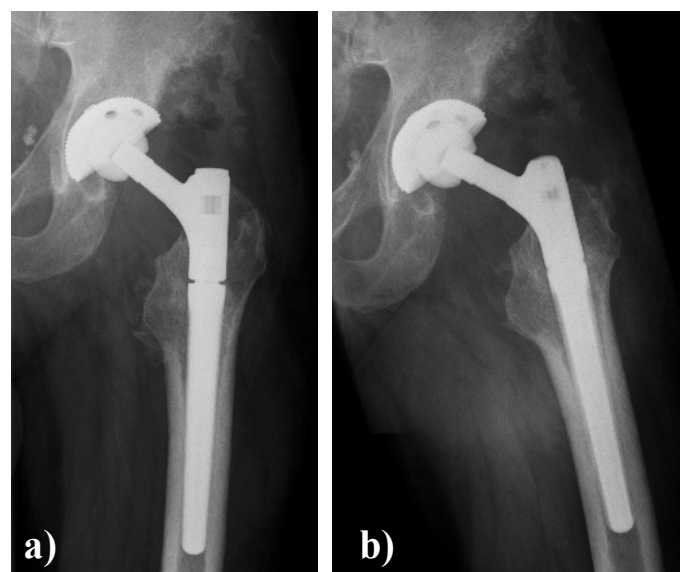
Figure 4. X-ray of the left hip in 2 planes: ap view a. and lateral; b view shows status after revision of THA using a long varus neck and a cementless cup.

(Figure 4). A ceramic on PE bearing was implanted (head diameter: 32 mm). Postoperative healing was uneventful. The patient was out of any complaints. In February 2016 the patient started suffering from slight thigh pain but detected crepitation in the region of the left hip. X-ray of the left hip in 2 planes in May 2016 revealed an asymmetrically gap of the stem / neck junction (Figure 5). During revision surgery of the left hip breakage of the cone of the morse taper junction was visible (Figure 6). Removal of the well-fixed stem was performed via a distal fenestration. After fixation with cerclage wires a bended MRP Titan revision stem (Diameter: 19 mm, Length: 200mm with long neck and extension sleeve) was implanted using a 32 mm ceramic head (Figure 7). Postoperative healing was uneventful.

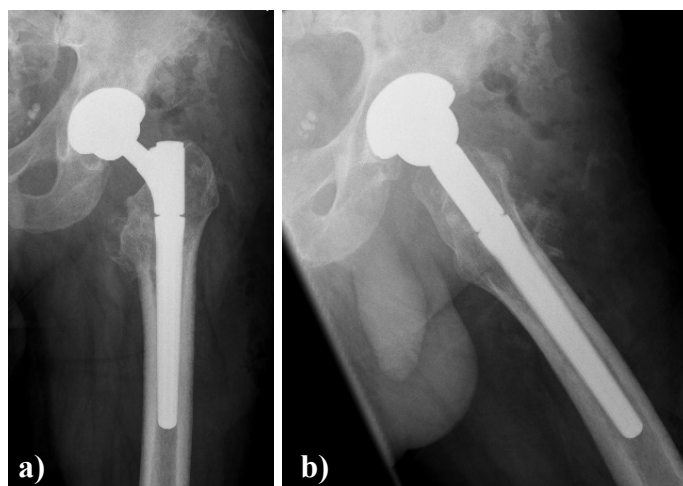
Figure 2. X-ray of the left hip in 2 planes: ap view a. and lateral; b. view shows THA using a MRP Titan revision stem with a short neck and a cementless cup.

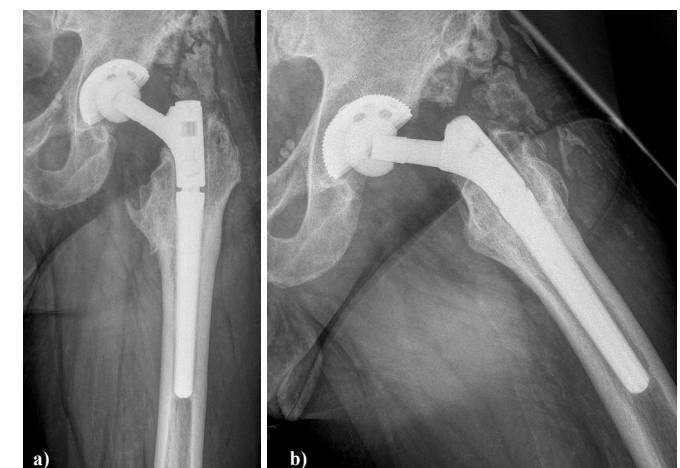
Figure 5. X-ray of the left hip in 2 planes: ap view a. and lateral; b. of the left hip reveals an asymmetrically gap of the stem / neck junction and radiolucent lines in zone 1,7,8, and 14 according to Gruen.

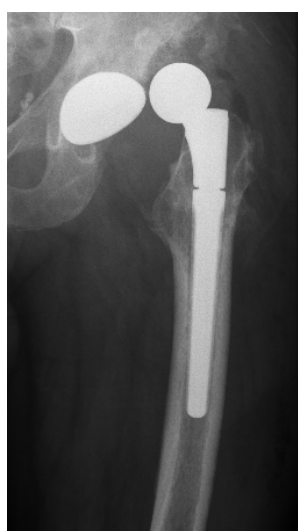
Figure 3. X-ray of the left hip (ap view) shows dislocation of the left hip.

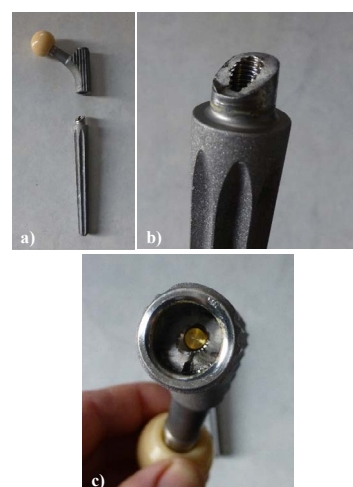
Light microscopy and field emission scanning electron microscopy (SEM, LEO 1525) was used for analyzing the broken cone. The fracture of the male cone showed typical secondary damage features attributed to handling, especially manipulation during explanation procedure. These never avoidable deteriorations hindered the possibility of analyzing the very starting point of the fracture. Additionally, hinderness was the fact that the overweight patient walked about 3 months with the broken cone. Globally the fracture is of a typical fatigue type, starting surprisingly deep inside the cone contact surfaces. To reveal specific features of the contact area at the crack initiation site we opened the distal part of the component exact axially in order to prepare carefully out the male cone residue. Light microscopy and

Figure 6. a and b showing the broken cone of the morse taper junction; c. view into the female part of the morse taper junction showing the broken cone and broken golden expansion screw.

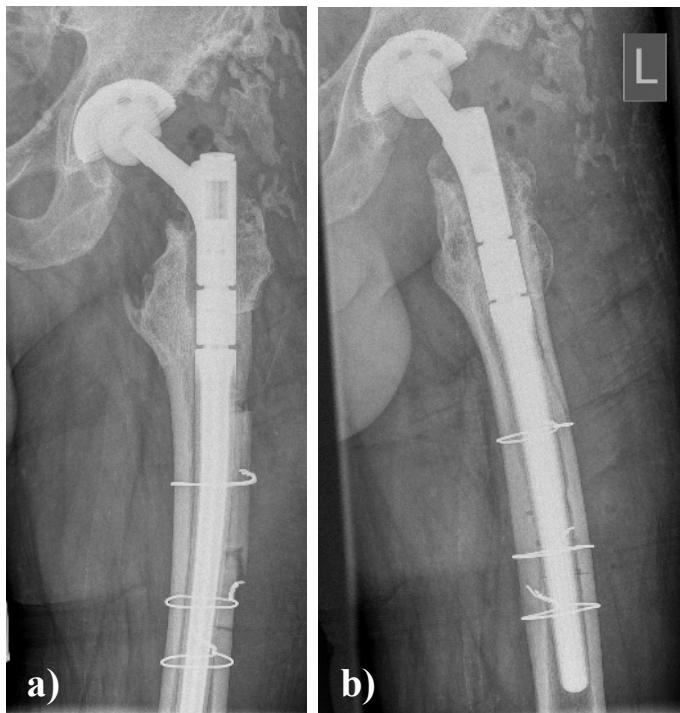
Figure 7. X - ray of the left hip in 2 planes: ap view a. and lateral; b. view shows revision arthroplasty of the hip using a long bended MRP Titan revision stem with long neck and extension sleeve.

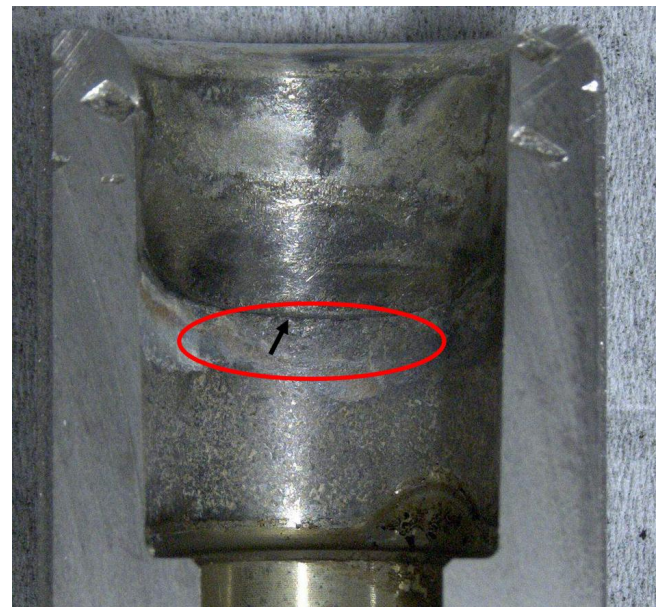
field emission scanning electron microscopy revealed fretting and crevice corrosion and fatigue crack (Figure 8-10). There were no signs of design or material flaws.

Figure 8. Insight of the female component: Border line of the crack path. Below the crack initiation site the contact cone surfaces show massive fretting and fretting oxidation (O).

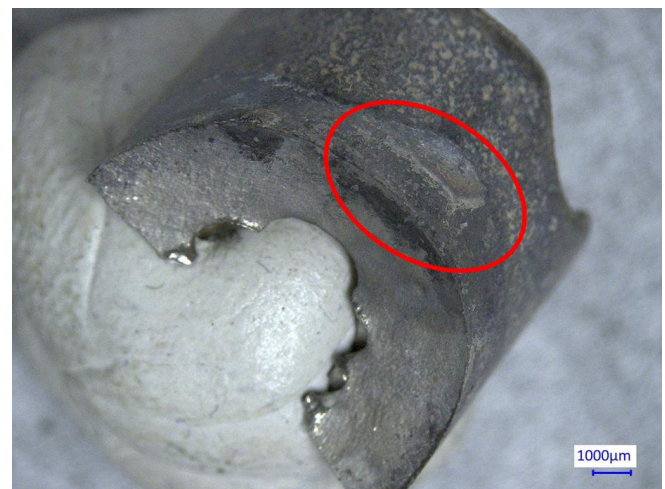
Figure 9. At the male cone the fretting features are also clearly visible (O). The surface below the contact fretting pattern additionally shows features of crevice corrosion.

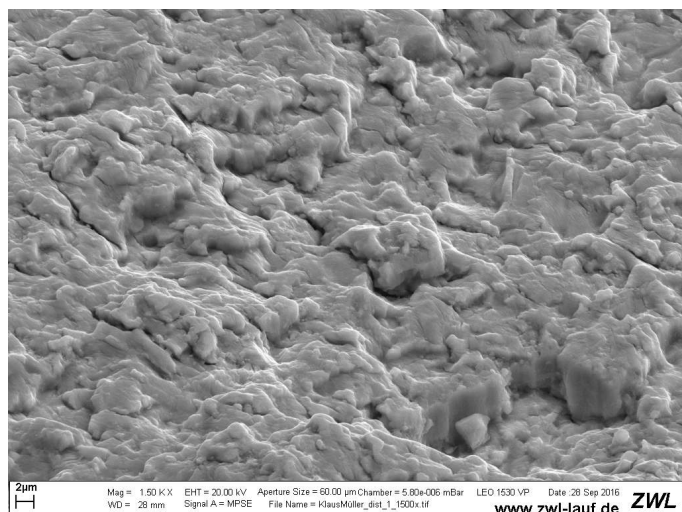
Figure 10. The crack surface itself reveals striations with very narrow distance, typical of a fatigue crack propagation with low velocity over a long period.
