Global management of a traumatic immature central incisor with an open apex and crown discoloration

The purpose of this report is to describe the global management of a coronal complicated fracture of a maxillary permanent central incisor # 21 with pulp necrosis, apical periodontitis within an open apex and crown discoloration.

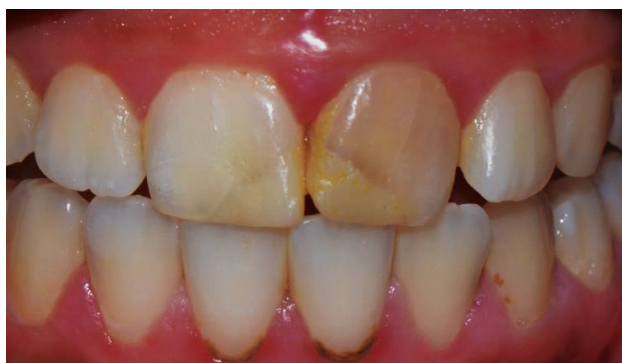
Clinical examination (Figure 1a) revealed defective resin composite restoration on teeth #21 and #11. Tooth #21 showed an access cavity already done, with a clear discoloration. Sensitivity tests showed positive response only on tooth #11. The tooth #21 was tender to percussion with a physiological mobility. The periodontal state was unhealthy. The gingiva was inflamed with plaque and calculus on teeth. Periapical radiographic examination (figure 1b) showed an immature open apex of the tooth #21 with a radiolucent lesion in the apical area.

Figure 1a. Initial clinical view of the anterior maxillary region: observe the defective restorations of teeth 11 and 21 with discoloration on tooth 21.

The diagnosis established was a chronic apical periodontitis with an open apex. Our treatment plan included an endodontic management followed by an internal bleaching, then restoration of the incisors with stratification layering technique using Composite Resin.

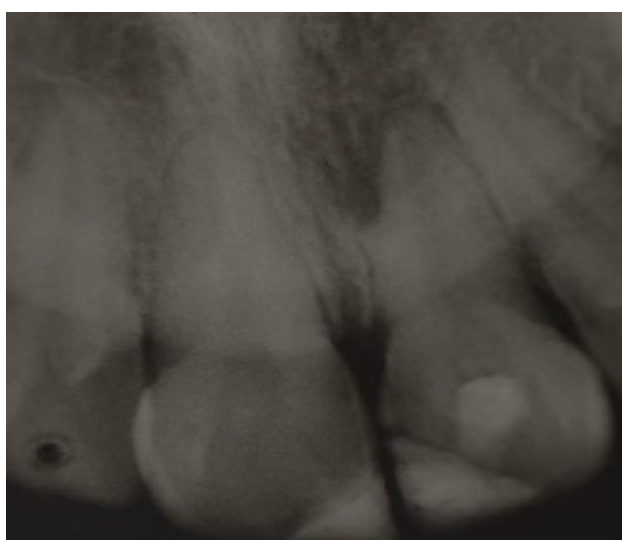
Figure 1b. A preoperative periapical radiograph of maxillary central region: observe open apex of tooth 21 with radiolucent area

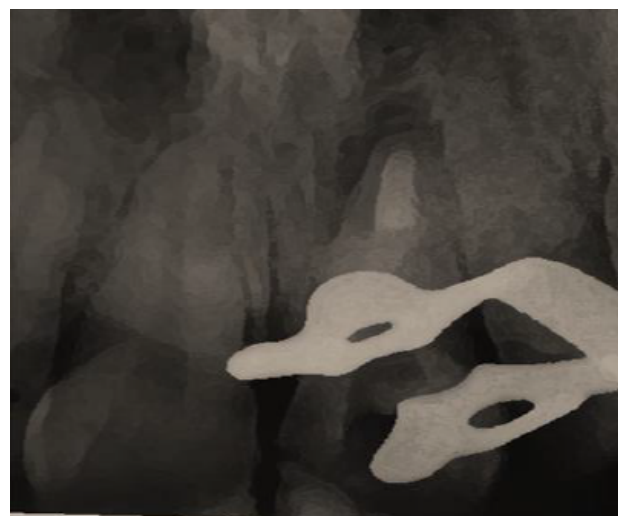
Figure 2b. Immediate postoperative periapical radiograph

To fit the MTA in the apical portion, 2 Machou pluggers number 2 and number 4 were chosen (silicone stop must be at Working Length (WL) – 2mm and at WL – 4 or 5mm respectively with a slight contact with root walls). The powder of MTA (Dental Tulsa Dentsply) was mixed with sterile water (figure 2a) following the manufacturer's instruction. Then, the mixture was carried into the canal using an amalgam carrier and gently condensed apically to create an apical plug of 4-5 mm of thickness. To check the correct position of the MTA mixture, an X-ray control was done immediately (figure 2b). A wet cotton pellet with sterile water was then placed in the pulp chamber and the access cavity was temporary sealed with IRM (Caulk/Dentsply, Milford, DE, USA). Two weeks later, the tooth was asymptomatic, so the rest of the canal was obturated with thermoplasticized gutta-percha (Revo® condenser, MicroMega). The final result of the obturation can be seen in figure 2c.

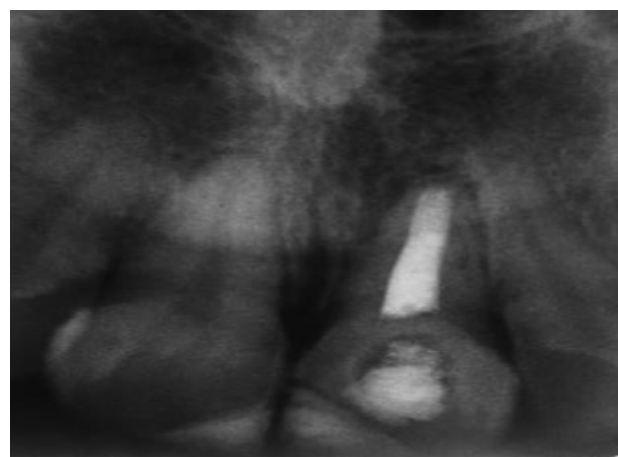
Figure 2c. Postoperative periapical radiograph of the canal obturation

Once the endodontic therapy was validated and the adequacy of the canal obturation was confirmed, the internal bleaching of tooth # 21 could began.

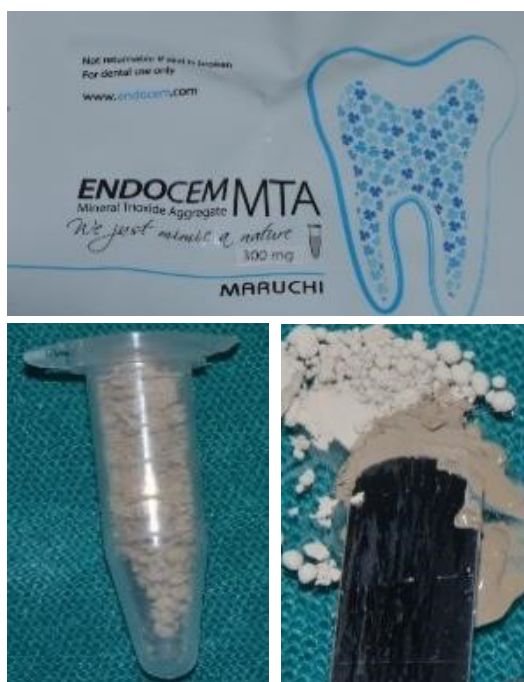
Figure 2a. MTA mixed with sterile water following the manufacturer's instructions

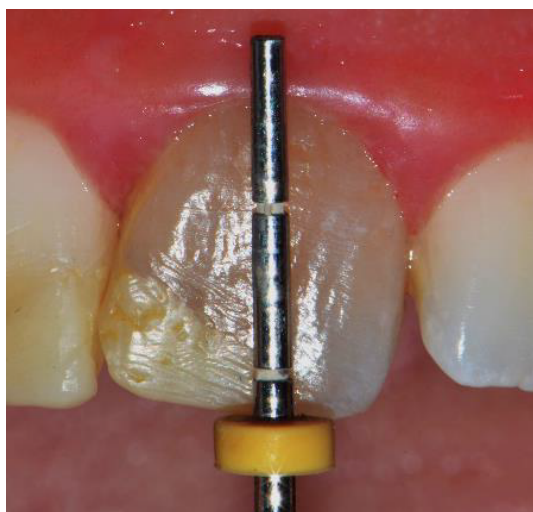
Figure 3a. Record barrier probing using a rubber stop to identify the labial depth

The barrier probing was recorded using a rubber stop to identify the labial depth (figure 3a) then transferred into the pulp chamber of tooth #21, to create an outline for the internal barrier on 2 mm to the cement enamel junction (figure 3b).

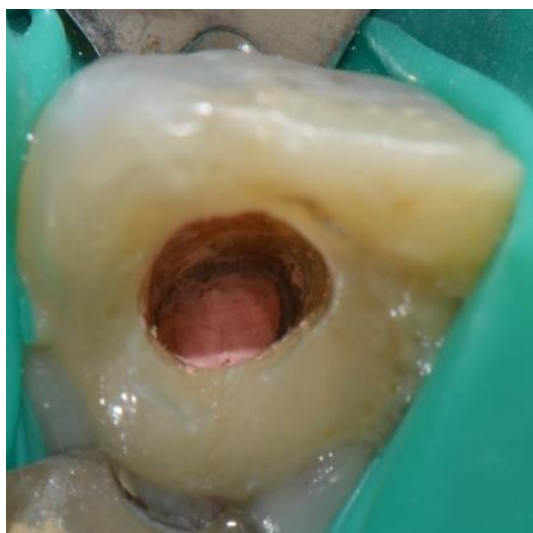
Figure 3b. Management of the outline for the internal barrier

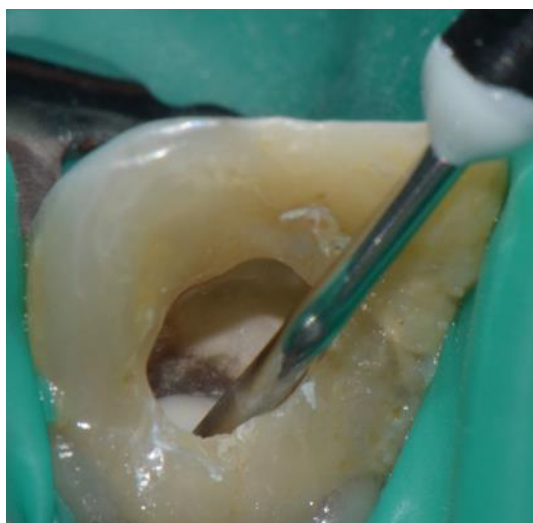
Figure 3c. Placement of the barrier material (light cured calcium hydroxide)

Light cured calcium hydroxide was placed as a barrier material (figure 3c) then polymerized for 20 seconds, so we could place the bleaching material (opalescence endo 37%) with application on the buccal and cervical walls. A small cotton covered the bleaching material and the access cavity was sealed with temporary filling material IRM (Caulk/Dentsply, Milford, DE, USA).

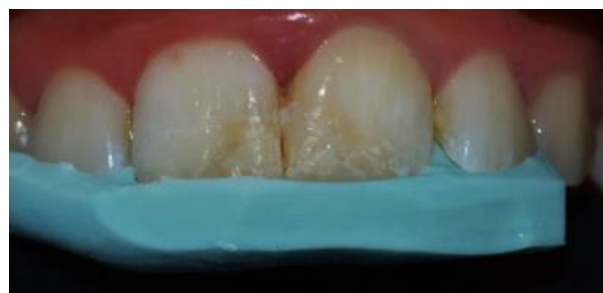
Figure 4a. Intraoral test of the silicone guide

After planning the restorative treatment, a silicone guide was fabricated from the wax-up cast model then intraorally tested (figure 4a). The color selection must be prior to rubber dam isolation because tooth dehydration may mislead the choice of the shade (figure 4b).

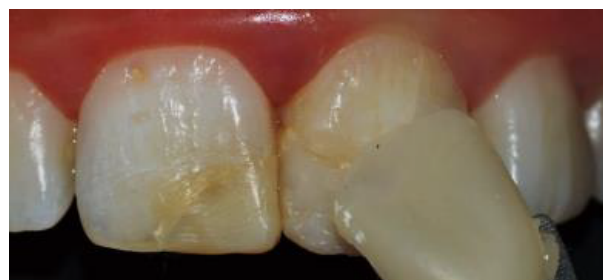
Figure 4b. Color selection

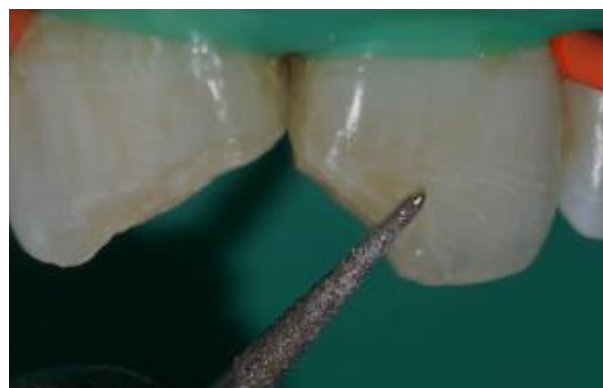
Figure 4c. Concave bevel on the enamel of the fracture area

After rubber dam isolation and removing of the old restorations, a concave bevel was made on the enamel of the fracture area with the aid of a flame-shape Diamond bur (figure 4c).

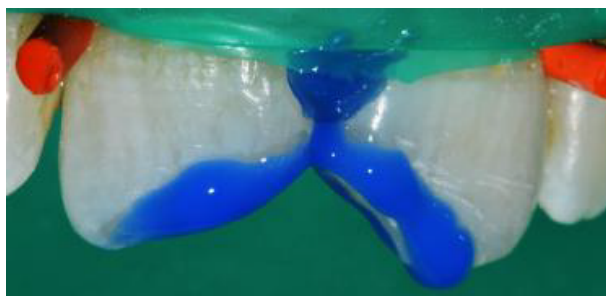
Figure 5a. Application of 37 % phosphoric acid gel over the enamel

A 37% phosphoric acid gel was applied for 10 seconds over the enamel (figure 5a) then over the entire tooth for 20 other seconds. Then, the tooth was washed with an air-water spray. The entire tooth surface was air-dried and the exposed dentin surfaces were re-wetted with a disposable brush (Cavibrush, FGM Dental Products).

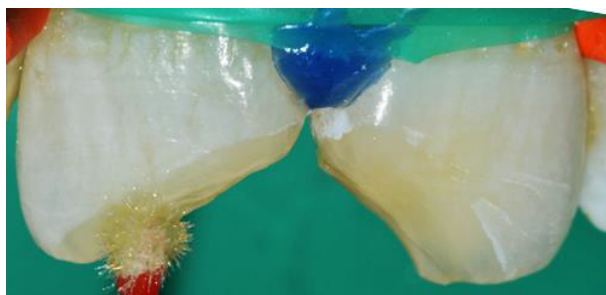
Figure 5b. Application of the adhesive system Adper Single Bond 2

Afterward, the adhesive system Adper Single Bond 2 (3M ESPE, St. Paul, MN, USA) was applied in two coats following the manufacturer's guidelines (figure 5b).

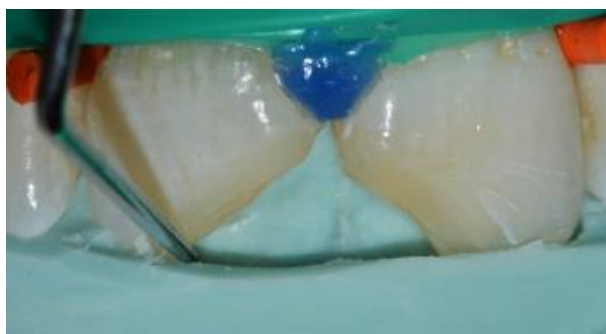
Figure 6a. Mark of the level fracture on the silicone guide using a probe

The level of the fracture was marked on the silicone guide using a probe (figure 6a). With a filling spatula, a small ball of translucent enamel microhybrid composite (T-Neutral shade, Opallis, FGM Dental

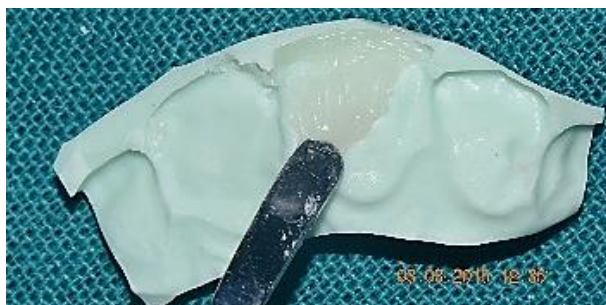
Figure 6b. A thin layer of translucent micro hybrid composite resin inserted on the guide

Products) was placed on the silicone guide and spread over the silicone guide surface (figure 6b), as this layer of composite was aimed to cover all the exposed dentin at the palatal surface. Care was taken to avoid the insertion of large air bubbles and also the application of an excessively thick layer of resin. Subsequently, the silicone guide was placed into position, and the first resin layer was polymerized for approximately 20 seconds with the same light-curing unit described earlier.

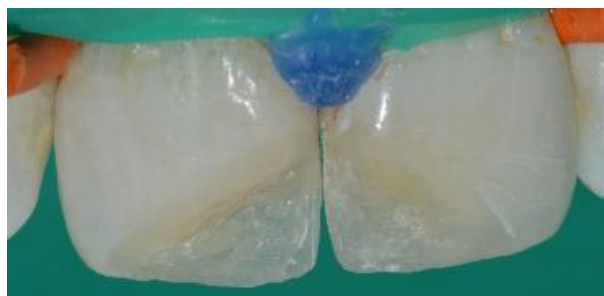
Figure 6c. Confection of the artificial palatal layer with enamel shade composite resin

The palatal wall obtained (figure 6c) was used as support for stratification of composite resin by layering technique using dentin and

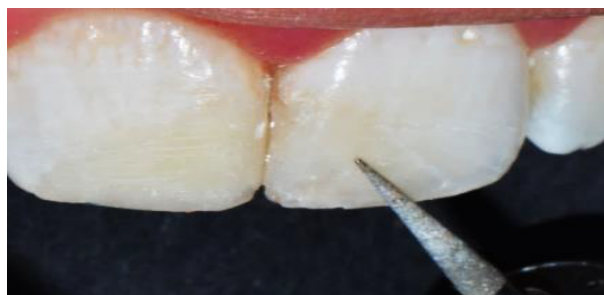
Figure 7a. The surface texture was re-created with a tapered fine diamond bur

Forty eight hours later, the patient returned to complete the finishing of surface. The surface texture was tapered with a fine diamond bur (figure 7a). Silicone abrasive cups and abrasive brush (figure 7b,7c) were used to eliminate undesired excessive texture. The interproximal regions were polished with abrasive strips.

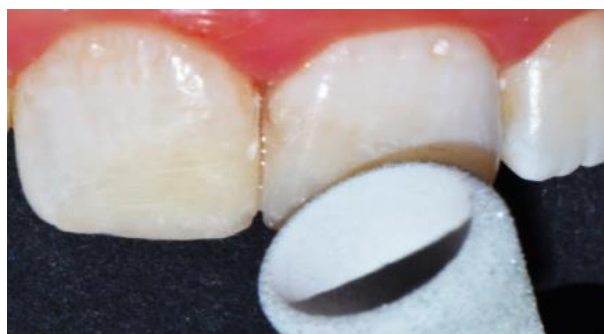
Figure 7b. Finishing of surface with silicone abrasive cups

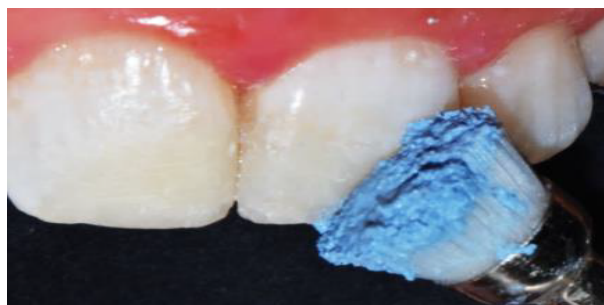
Figure 7c. Polishing with abrasive brush

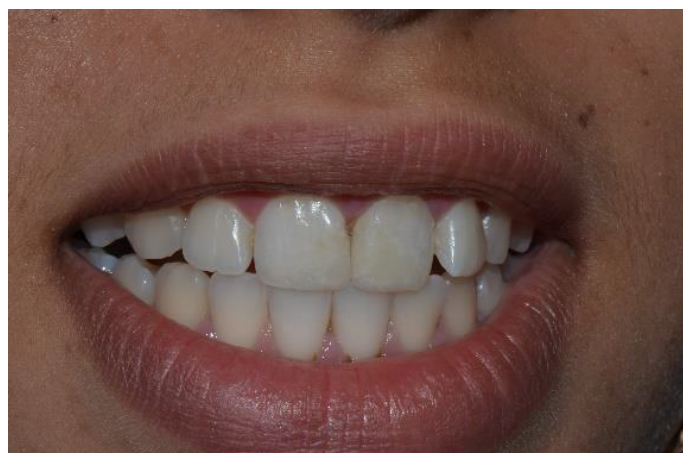
Figure 8. Postoperative photograph of the patient's smile

A smile photograph of the patient was taken as shown in figure 8.
