Case Report

Intraoperative failures of the PFNa II spiral blade

Department of Orthopaedics and Traumatology, North District Hospital, Sheung Shui, Hong Kong SAR, China

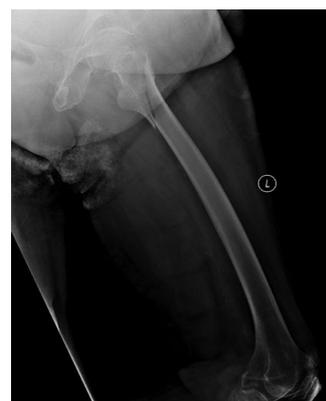
Figure 1. Displaced trochanteric fracture of left femur with sub-trochanteric extension was noted (lateral view).

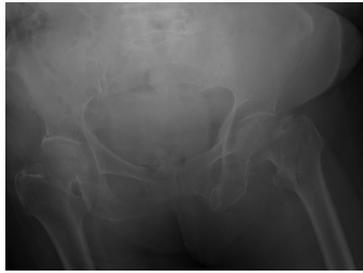
Figure 2. Displaced trochanteric fracture of left femur with sub-trochanteric extension was noted (AP view).

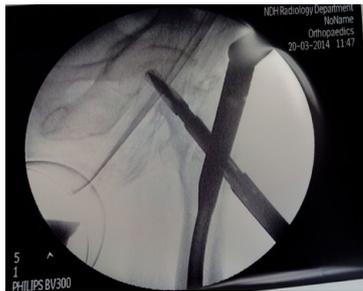
Figure 3. The blade was found to remaining unlocked in intraoperative X-ray screening even the impactor was able to separate from the spiral blade (AP view).

One possible reason for failure to lock the blade may be due to over-tighten of the blade. It may destroyed the thread within the blade and disturb the locking mechanism of impactor – blade assembly. On the other hand, jamming of soft tissue between the blade and impactor during advancement can prevent successful locking. If the blade was not attached to impactor correctly and the sleeve was not pushed to reach lateral cortex of femur, there might be possible that soft tissue jammed in the gap between the impactor and blade and disturbed the locking mechanism. The other possible mechanism was that the cancellous bone can be packed tightly around the blade during its advancement. The tightly packed bone around the blade might be tough enough to resist the proper rotation and locking of the blade. Finally it may due to that implant intrinsic problem, but we need to wait for the formal report of the manufacturer.

The blade needed to be removed and replaced by a new one. However, the tunnel created by the old blade will jeopardize the bone purchase of the new blade, particularly in those geriatric patients with poor bone quality. To avoid this, we can skip creating the drill hold for PFNa blade in those with poor bone quality or we can pack bone substitute or autograft/allograft into the tunnel before inserting the new blade.

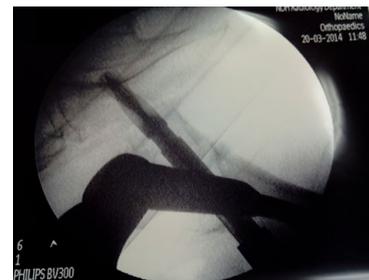
Figure 4. The blade was found to remaining unlocked in intraoperative X-ray screening even the impactor was able to separate from the spiral blade (lateral view).

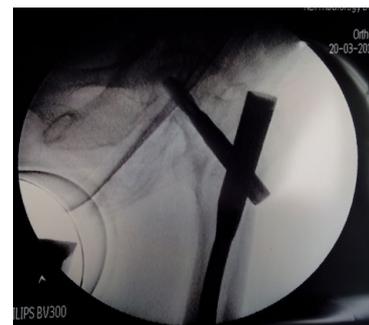
Figure 5. New spiral blade was able to lock smoothly, good implant position and alignment was confirmed with intraoperative screening (AP view).

excessive angulation of the jig for femoral anteversion. The surgeon decided to extract out the blade and inserted another new PFNa II blade (85 mm). Before the new blade insertion, apart from checking the free rotation of the helical blade, it was checked for the successful locking unlocking to make sure that there was no mal-functioning of the locking mechanism. The bone purchase was good and the blade was able to lock smoothly (Figure 5 and 6) at this time. The total operative time was 2 hours and 46 minutes. Total blood loss was around 200ml.

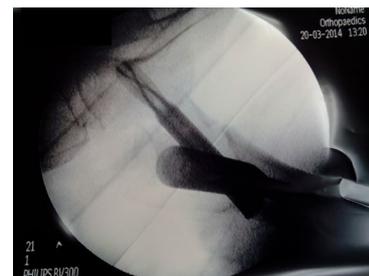
Figure 6. New spiral blade was able to lock smoothly, good implant position and alignment was confirmed with intraoperative screening (lateral view).

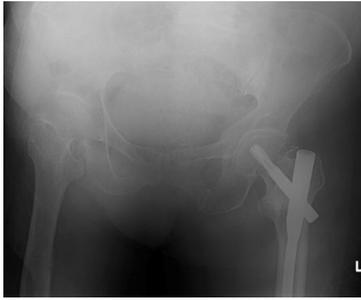
Figure 7. Post operative fracture alignment well and implant was in good position (AP view).

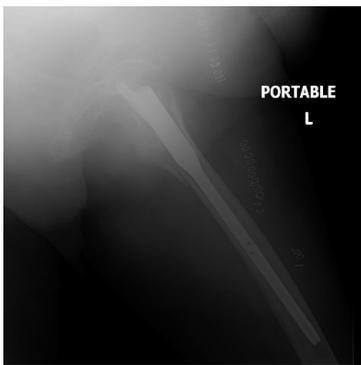
Figure 8. Post operative fracture alignment well and implant was in good position (lateral view).

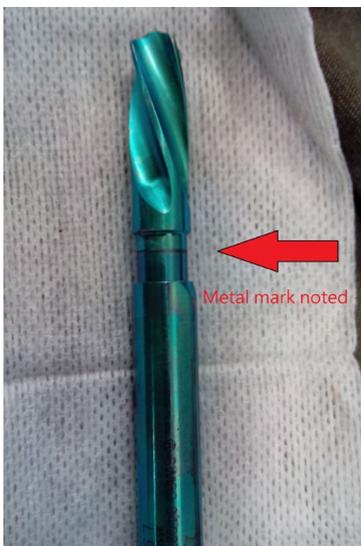
Patient was stable all along post-operatively and tolerated full-weighted bearing walking exercise without any pain. Post-operative X-ray was performed showed the implant was in situ with good alignment (Figure 7 and 8). Examination of the spiral blade postoperatively noted there was an unusual metal mark on the body of the blade and it could not be fully locked. (Figure 9 and 10)

Figure 9. An unusual metal mark on the body of the blade .

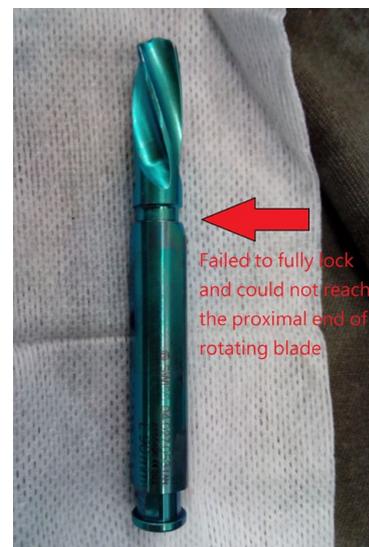
Figure 10. An unusual metal mark on the body of the blade, it could not be fully locked and reach the proximal end of the rotating blade part.

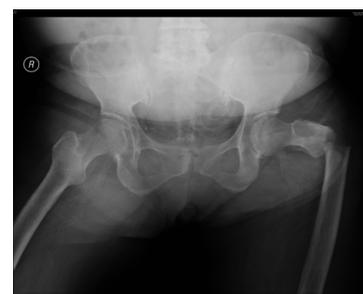
Figure 11. Subtrochanteric fracture of left femur showed in AP X-ray.
