Journal of Cardiology Case Reports

Case Report

Different findings after PCI with both DES and BVS in a patient with coronary artery ectasia – A case report

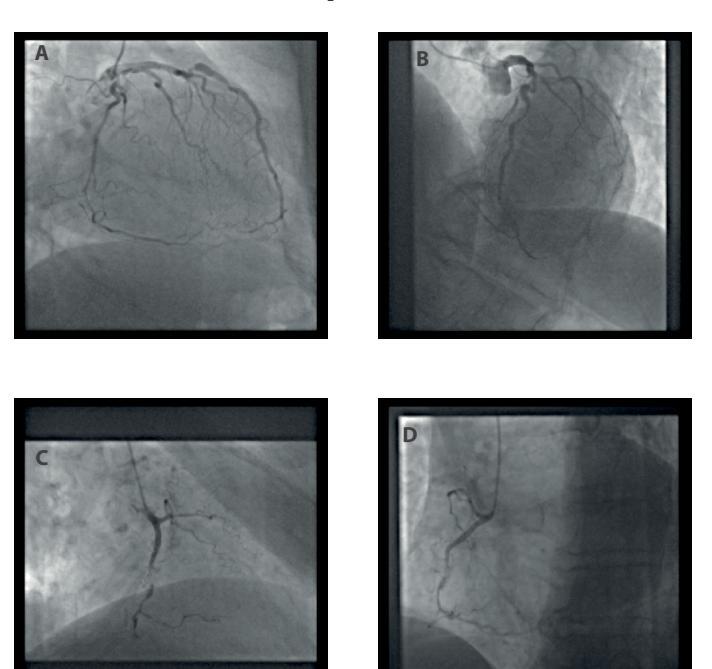
Figure 1. Coronary angiography (16.01.2020). A + B: left coronary artery. Note the retrograde filling of the distal right coronary artery. C +D: right coronary artery.

In January 2020, a 69 years old female patient with a history of hypertension and smoking was admitted to our department due to stable angina CCS 3. Echocardiography showed normal left ventricular function and elective coronary angiography revealed 2 vessel disease with chronic total occlusion of the mid right coronary artery (RCA) and high degree stenosis of the left artery descending (LAD). Additionally, mid LAD showed an ectatic vessel segment directly adjacent to the stenotic lesions (Figure 1). As the patient refused bypass surgery, a staged PCI was planned starting 14 days later with the CTO-PCI of the RCA where 3 DES were implanted (DES Promus Premier Select, Boston Scientific, USA; sizes: 3.0 x 38mm; 3.0 x 38mm; 3.5 x 24mm (Figure 2). 3 months later (22.04.2020), the patient was scheduled for elective PCI

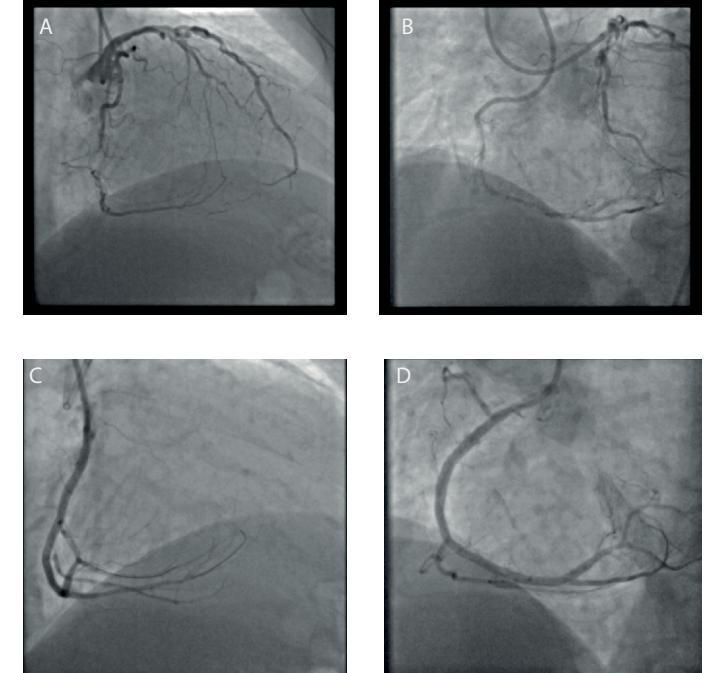
Figure 2. Percutaneous coronary intervention of right coronary artery (RCA) with implantation of 3 drug-eluting stents (31.01.2020). A + B: before PCI (simultaneous injection into left and right coronary artery). C + D: RCA after PCI.

In our patient suffering from angina CCS 3 arising from 2 vessel disease, a strategy of staged PCI was pursued. We started with the PCI of the RCA which was successfully completed with the implantation of 3 DES. Although intracoronary imaging of the acute result of this PCI was not performed, angiography indicated proper stent sizing and no signs of procedural complications. 3 months later, PCI of the LAD was scheduled which a priori was a complex situation because the target stenosis was in direct neighborhood with a dilated vessel segment so that

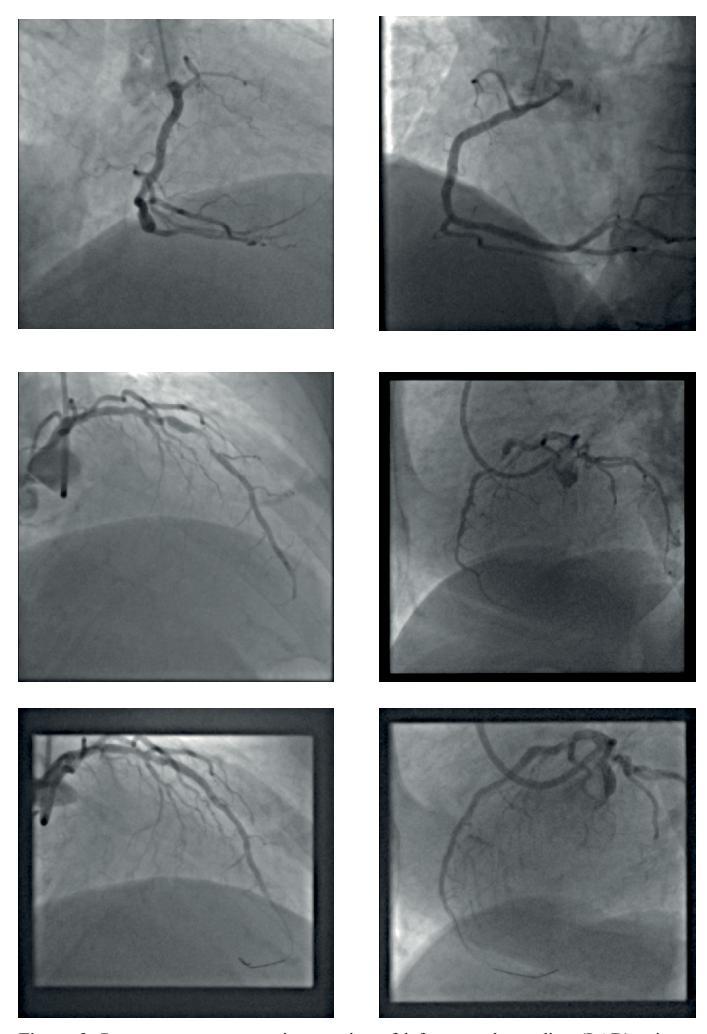
Figure 3. Percutaneous coronary intervention of left artery descending (LAD) using a Magmaris bioresorbable scaffold (22.04.2020). A+ B: angiography of right coronary artery (no further intervention). C + D: LAD before PCI. E + F: LAD after PCI with Magmaris

of the mid LAD. At this time, angiography showed a patent RCA (Figure 3). Due to the ectatic vessel segments of the LAD directly neighboring the stenotic lesions, it was planned to perform the PCI using a magnesium-

based bioresorbable vascular scaffold as it could be expected that any part of the scaffold that did not reach the ectatic vessel wall would be resorbed rapidly thereby avoiding persisting malapposition of stent struts which otherwise would harbor the potential risk of late stent thrombosis. After an uneventful procedure with implantation of one BVS (Magmaris, Biotronik, Germany; size: 3.5 x 25mm; post-dilatation with 3.5mm NC balloon; Figures 3 and 4), the patient was sent home the next day and kept on dual antiplatelet therapy (DAPT). Before the planned cessation of DAPT, an elective repeat angiography was performed on 24.03.2021. As seen from Figures 5 and 6, the LAD was found without signs of restenosis or progression of the ectasia and the implanted magnesium BVS was completely resorbed. On the other hand, OCT of the RCA showed several sites with late malapposition of the implanted DES probably due to the new development of coronary artery ectasia (Figure 7). The decision was made to implant another 3 DES in order to achieve complete stent apposition (Orsiro, Biotronik, Germany; sizes: 4.0 x 13mm; 4.0 x 15mm; 4.0 x 13mm; post-dilatation with 4.5mm NC balloon) (Figure 8). The patient was advised to stay on DAPT for another 6 months and to undergo repeat intracoronary imaging before stopping clopidogrel.

the risk of acute stent malapposition had to be considered. Therefore, after individual risk- benefit evaluation the decision was made to use a bioresorbable Magmaris-BVS to treat this lesion. The decision was based on the assumption that the stenosis would be sufficiently covered by the BVS whereas in segments where the scaffold would not reach the ectatic vessel wall an accelerated resorption of the "malapposed" struts would take place. The magnesium-based Magmaris-BVS was preferred over other BVS as it had been shown previously that PLLA-based scaffolds are linked to unfavorable longterm outcomes [5] which has not been described for Magmaris [6,7]. 11 months later, follow-up examination indeed showed an excellent morphological result in the LAD without restenosis and complete resorption of the scaffold as intended. However, OCT analysis of the previously implanted DES in the RCA indicated significant late acquired stent malapposition. In

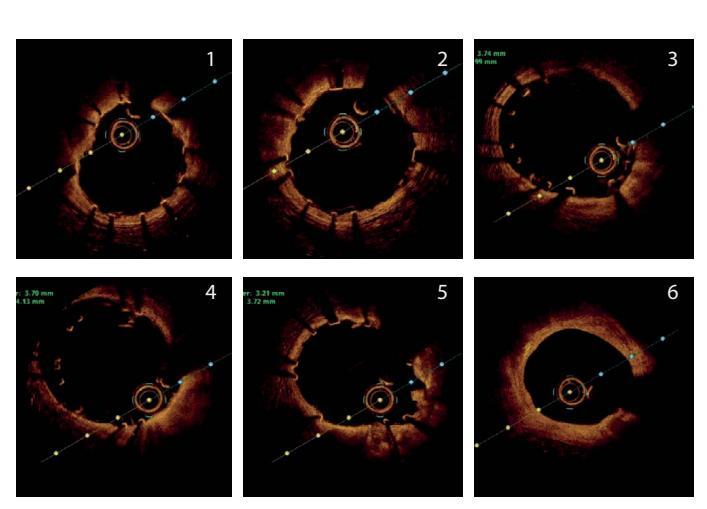
Figure 4. Optical coherence tomography of left artery descending from distal (1) to proximal (6) after implantation of Magmaris-BVS (22.04.2020). The "malapposition" of the Magmaris- BVS in (2), (3) and (4) was taken into account without further intervention due to the anticipated resorption of the struts.

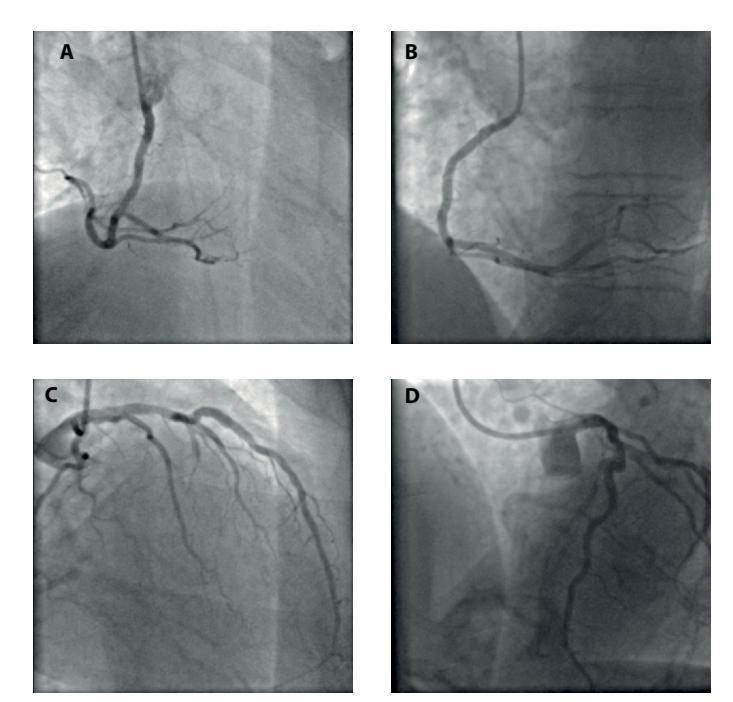
Figure 5.Coronary angiography (follow-up, 24.03.2021). A + B: right coronary artery. C + D: left coronary artery.

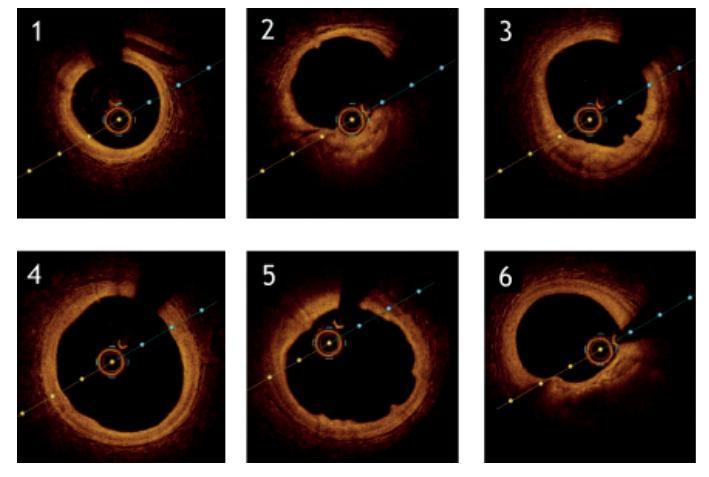
Figure 6. Optical coherence tomography of left artery descending (LAD) from distal (1) to proximal (6); Magmaris-BVS has been resorbed completely with some typical residual "humps" seen at the endoluminal vessel wall (24.03.2021).

Taken together, we present the case of a patient with coexisting CAE and symptomatic 2 vessel ASHD that was treated by PCI using DES in one vessel (RCA) and a magnesium based BVS in the other (LAD). Follow-up examination revealed late acquired stent malapposition in the DES-treated artery due to progression of the CAE whereas the lesion treated by BVS showed an excellent result. We believe that this finding warrants further investigation in clinical trials.

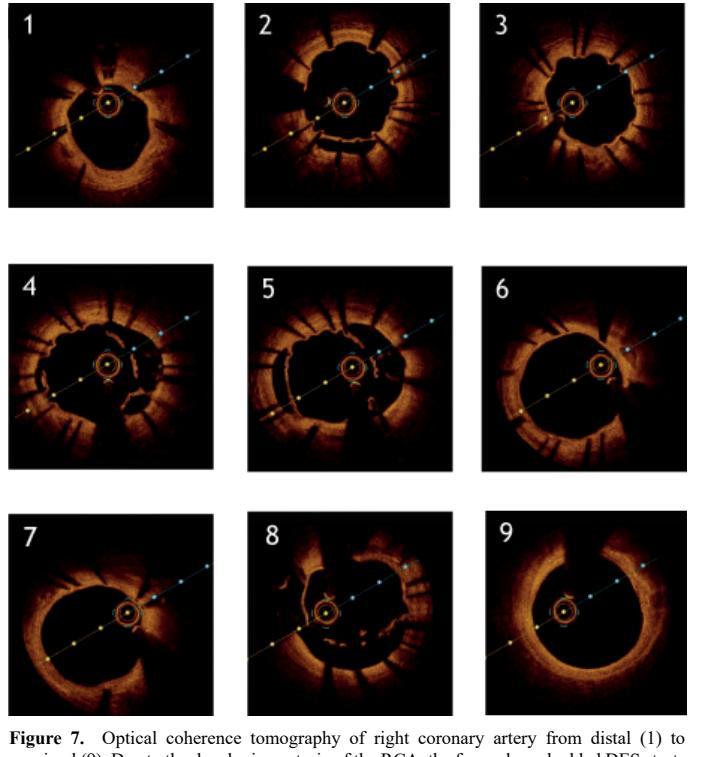
Figure 7. Optical coherence tomography of right coronary artery from distal (1) to proximal (9). Due to the developing ectasia of the RCA, the formerly embedded DES struts now are malapposed (24.03.2021).

general, it has been described that after CTO-PCI malapposed stent struts are a frequent finding due to several reasons [8]. Nevertheless, in our patient we consider the development of coronary ectasia as the main reason for the extensive late malapposition according to the morphological appearance (tissue bridges between the struts) although this can't be proven definitely.

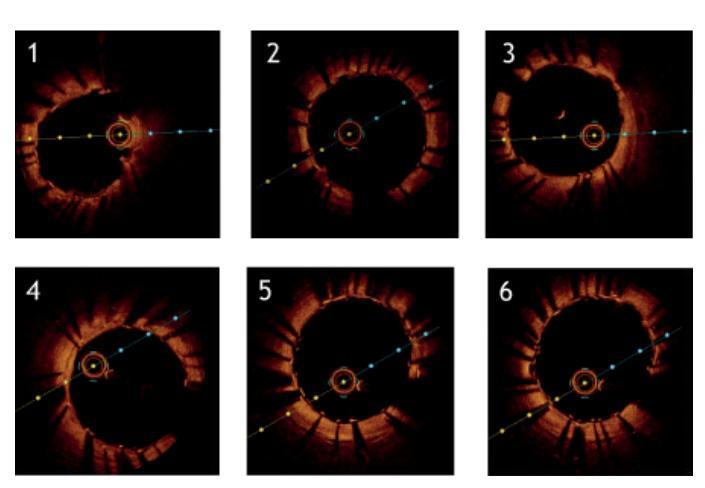
Figure 8. Optical coherence tomography of right coronary artery from distal (1) to proximal (6) after additional DES implantation (24.03.2021).

We decided to treat the late malapposition of the DES by implantation of further stents of a larger diameter which finally corrected the finding as seen from OCT. This strategy was based on data from previous studies that have emphasized the role of stent malapposition as a major factor of late stent thrombosis and myocardial infarction [9-11] although so far there are no prospective studies which have shown a benefit of any specific therapy in this situation.
